Wisconsin Department of Natural Resources
Inland Waters Trout Stamp Expenditure Report
Fiscal Years 2019-2021

Bureau of Fisheries Management
Administrative Report No. 102

This document summarizes expenditures of the Inland Waters Trout Stamp (IWTS) Program by the Bureau of Fisheries Management for fiscal years (FY) 2019 (July 1, 2018 – June 30, 2019), 2020 (July 1, 2019 – June 30, 2020) and 2021 (July 1, 2020 – June 30, 2021).

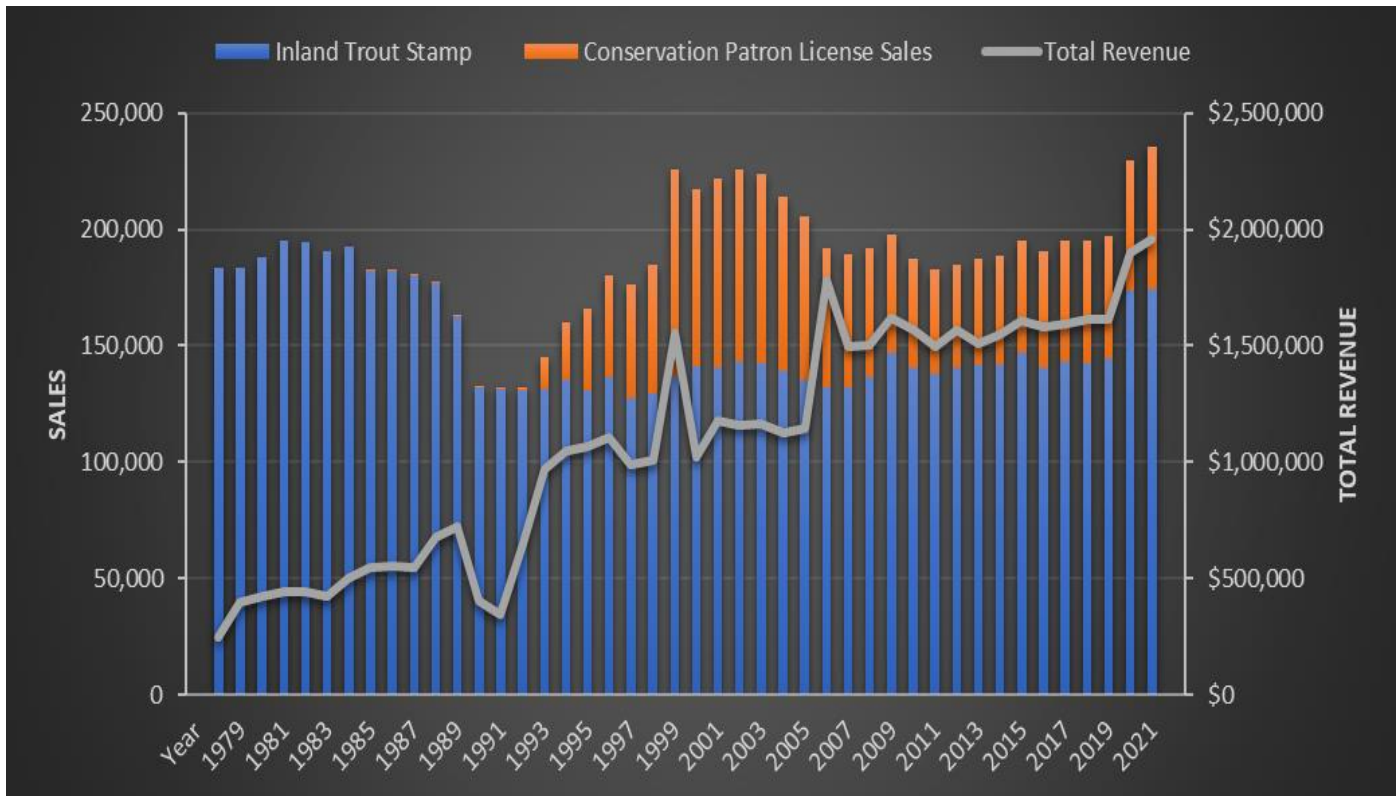
Figure 1. Trout stamp sales, patron license sales and total license revenue from 1978 – 2021. The spike in sales in 1999 was due to implementation of the Automated License Issuing System (ALIS). The spike in revenues in 2006 was due to the fee increase and a rebate from the surplus in the heavy equipment pool. A spike in sales occurred in FY2020 and FY2021 during the COVID-19 pandemic.

* A spike in sales occurred in FY99 due to implementation of the Automated License Issuance System (ALIS) and in FY20 and FY21 during the COVID-19 pandemic.

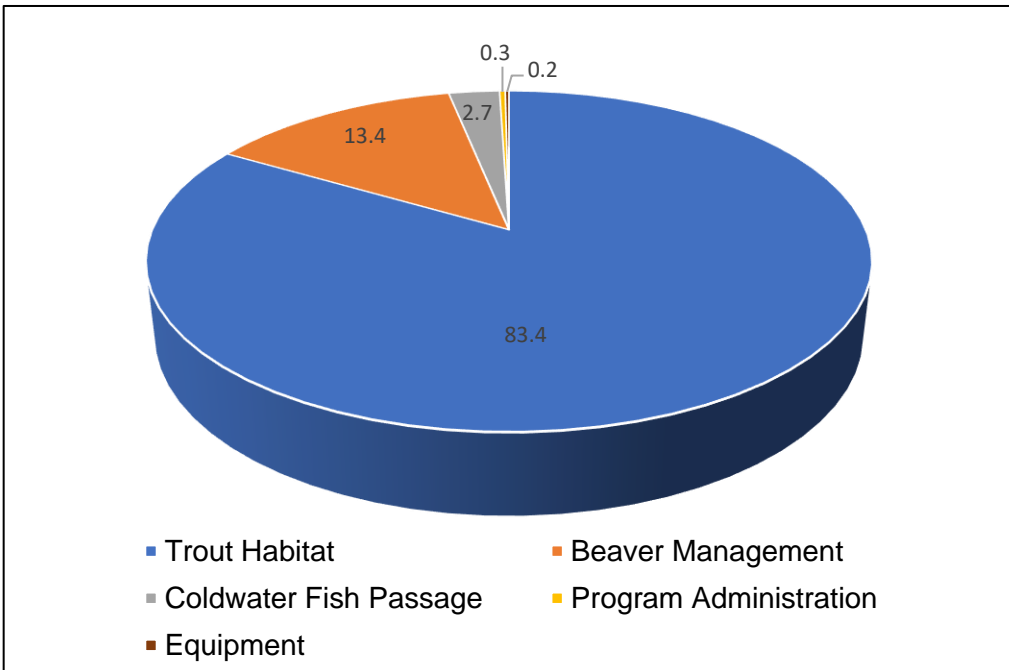
Figure 2. Percent of total expenditures for all activities FY2019 through FY2021

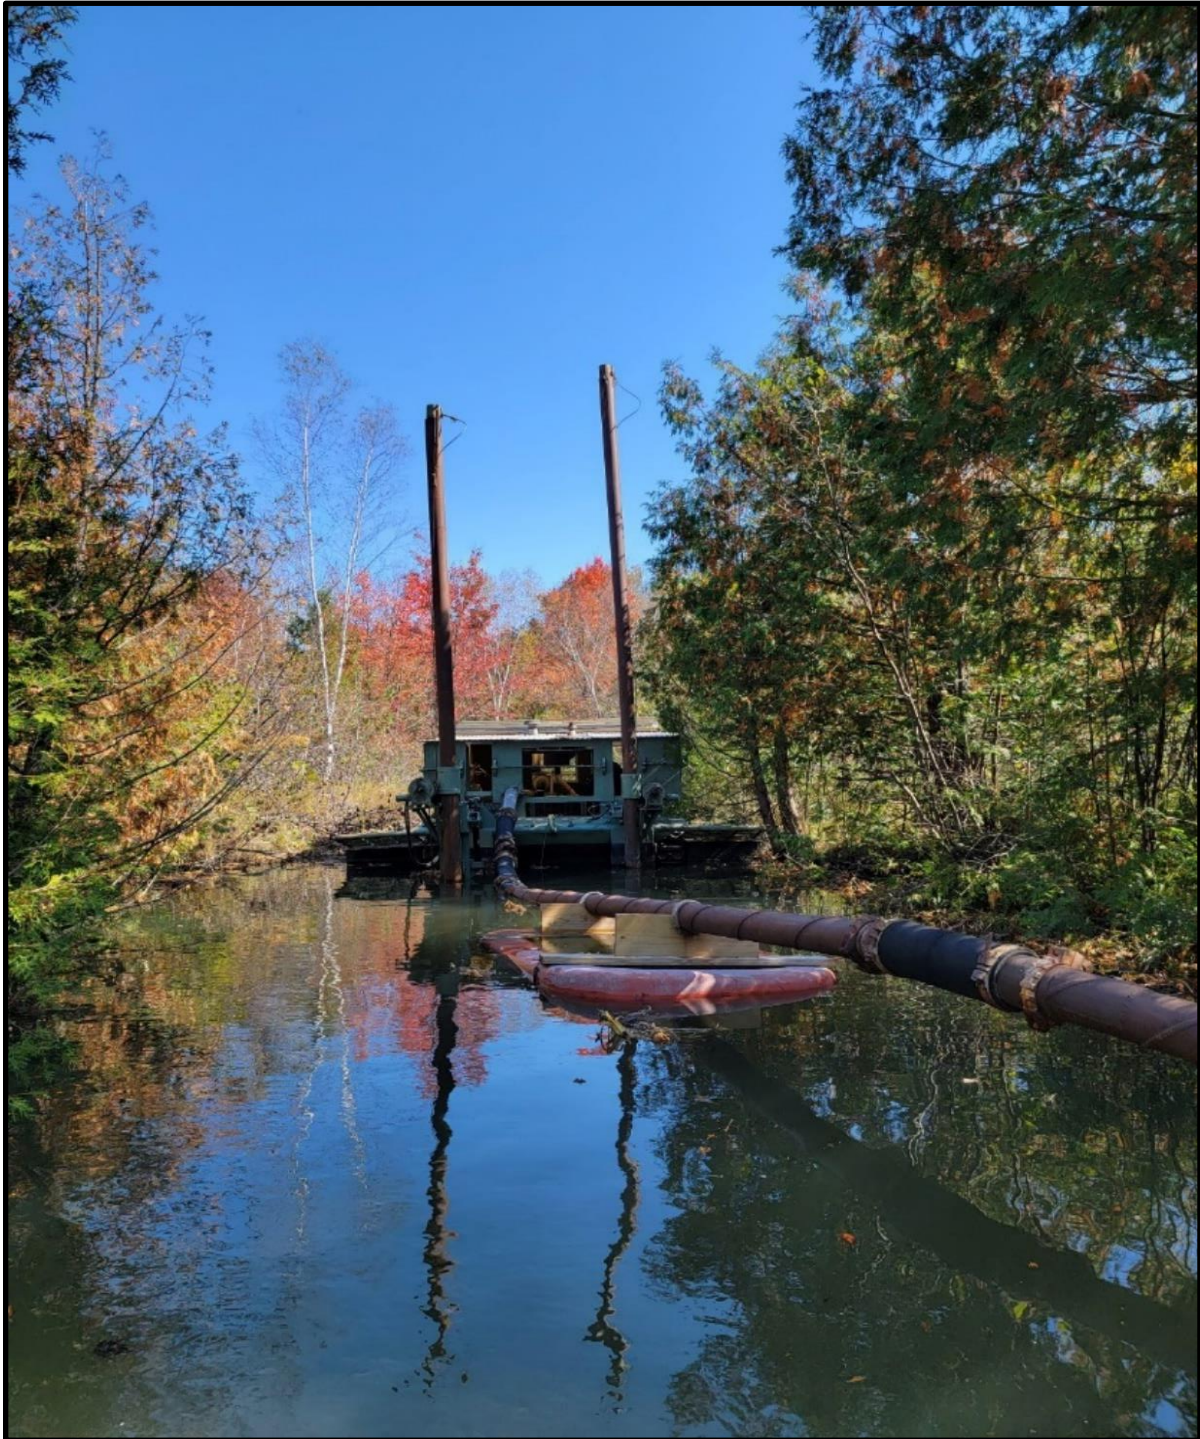
Dredging at the confluence of the Stillhouse spring pond and Lost Spring spring pond outlet creeks / Photo credit: Wisconsin DNR

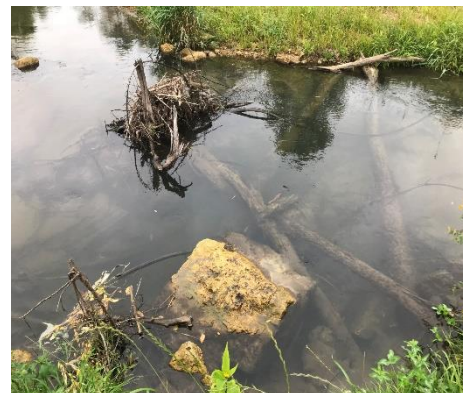
Installed root wad / Photo credit: Wisconsin DNR

As the name suggests, root wads are just that: root wads from trees, which may be suspended in the water column or resting on the substrate. They may be fully submerged or extend above the water’s surface. In addition to trout habitat, they also provide habitat for non-game and terrestrial species, including turtles and birds. Winged insects can also use them to deposit eggs in the water and for habitat when they are in aquatic life stages. Root wads provide excellent overhead cover, resting areas, shelters for insects and other fish food organisms, substrate for aquatic organisms, and increased stream velocity that results in sediment flushing and deeper scour pools.

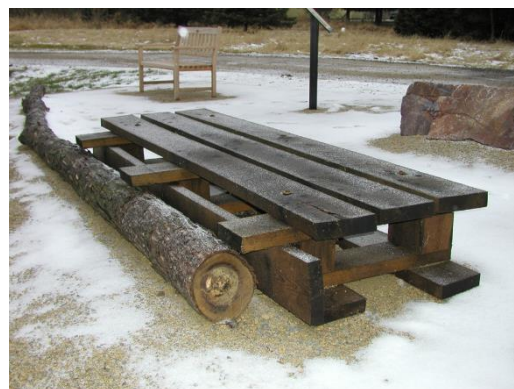
LUNKERS / Photo credit: Wisconsin DNR

Designed for the Driftless Area to increase the combination of pool and overhead cover habitat for adult trout in high-gradient streams that have cobble and rubble substrates. They are a prefabricated, sandwich-like wooden platform that rests directly on the stream bottom. They are constructed with oak planks that form the platform and stringers. Oak blocks or spacers are used to create the space where the trout hide. Each platform may be anchored in place by several pieces of rebar driven into the coarse substrate.

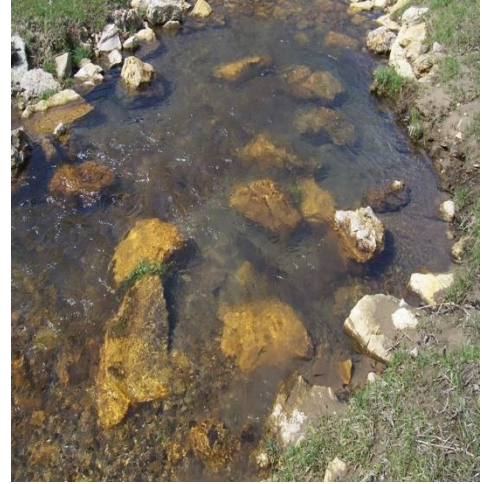
Midstream boulders / Photo credit: Wisconsin DNR

Midstream boulders, sometimes referred to as instream boulders, provide flow breaks for trout in stream reaches with run type habitat, which would otherwise be featureless and homogenous. Current/flow breaks are essential in run type habitats because they provide small pockets of reduced flows, allowing for simultaneous energy conservation and increased foraging ability for trout. They also increase habitat heterogeneity in areas where installing other habitat structures would be impractical because of depth and/or flow restrictions. Midstream boulders are installed mid-channel or near the edge of the channel not connected to the streambank. Coarse cobble substrate provides a stable bottom for the placement of midstream boulders while still allowing the water to scour around and behind them to create small pools.

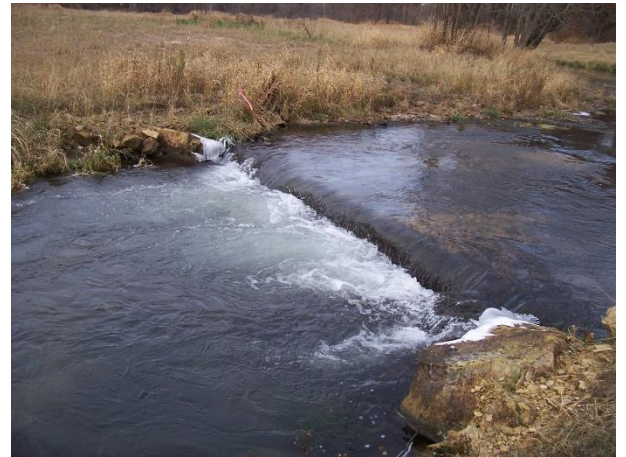
Cross logs are logs that are installed to transect the stream channel. They may be placed at any angle depending on where one would want to direct the flow. Water will flow over the log at 90°, creating deep pools for overhead cover and resting areas for trout and preventing any head cutting in higher gradient streams. Head cutting is a process of active erosion in a channel caused by an abrupt change in slope or plunge. The water undercuts bed material collapsing the upper edge. This process, left unattended, will advance upstream.

Crosslog / Photo credit: Wisconsin DNR

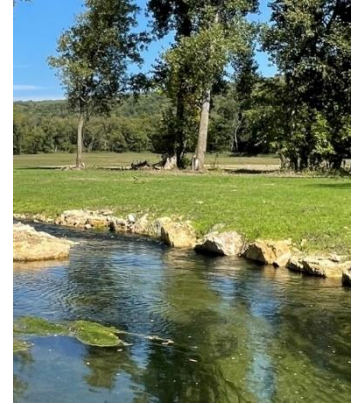
Bank boulders are groups of large rocks placed along a streambank edge to improve habitat and create scour holes and areas of reduced velocity. Placing the boulders on the streambank edge creates eddies, which create overhead cover for fish by partially diffusing sunlight. Bank boulders can also generate scour that cause pockets of deeper water to develop, which adds to the physical diversity of the stream.

Bank boulders / Photo credit: Wisconsin DNR

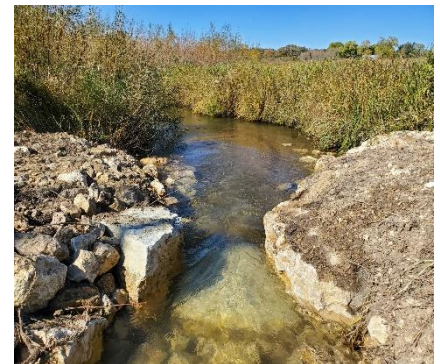
ERO / Photo credit: Wisconsin DNR

Gradient compromised streams need some type of constrictor, choke point or narrowing to accelerate the water and scour the sand away. Elevated Riparian Optimization (ERO) is a feature that helps do this. It is a type of Bernoulli structure that narrows the stream, increases its velocity, elevates the riparian and optimizes the force of the water. During low water or normal water flows, there is little noticeable effect, but when torrential rains fall, the added water volume and subsequent increased velocity potential provide enough energy to scour sand. These features create feeding and overwintering areas for trout. Bernoulli structure is named after the Bernoulli principle, established by Swiss physicist Daniel Bernoulli. Water passing through such a structure gains kinetic energy which helps maintain a plunge pool or scour hole.

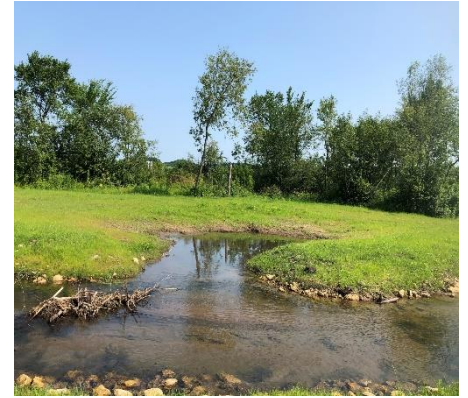
Backwater refuge / Photo credit: Wisconsin DNR

These shallow water structures created adjacent to the stream create ideal habitat for reptiles, amphibians and insects, along with smaller size fish. Young of the year trout may also use these in the spring as water temperature increases faster than the temperature in the mainstem of the stream.

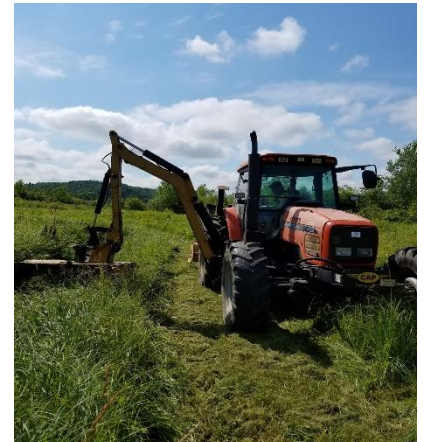
Streambank mowing / Photo credit: Wisconsin DNR

The objective of streambank mowing is to maintain a grass riparian area. Each habitat project is mowed on a 4-year rotation, providing sustained grassland riparian area and desirable angler access.

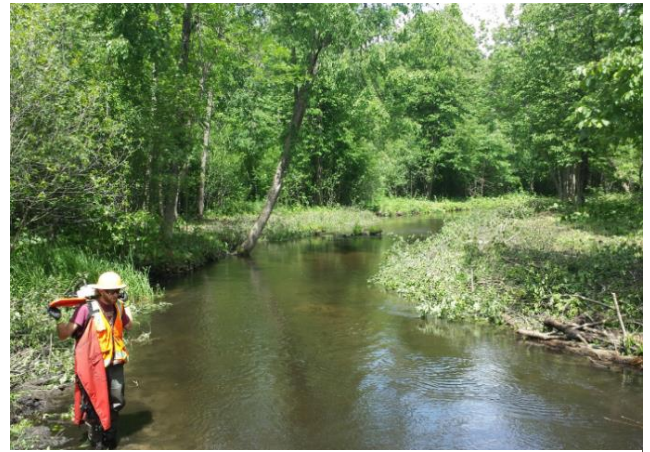
Post-fishability project. Notice the brush bundles installed along the streambank using material from the brushing project / Photo credit: Wisconsin DNR

This trout stream restoration technique focuses on improving the ability of anglers to freely travel and cast through a given stretch of stream that is otherwise unfishable due to excessive woody vegetation growth. Benefits of fishability brushing include being a cost effective treatment, providing ample space for casting, improving access along streams, helping eradicate invasive species, reducing competition for native species, increasing sunlight penetration to streambed, promoting aquatic vegetation growth, increasing sunlight penetration to streambank and promoting streambank stabilizing grass and forb growth. Material brushing projects may also be recycled into brush bundles and installed along the streambanks,

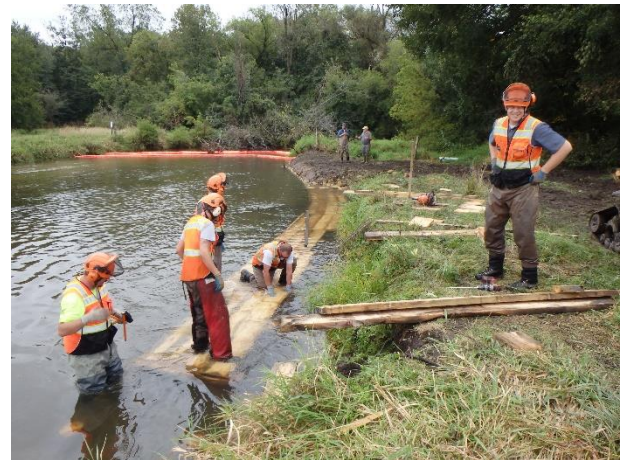
Bankcover installation / Photo credit: Wisconsin DNR

Bankcovers can be an extremely important technique when restoring trout stream habitat. Bankcovers replicate naturally occurring undercut streambanks, which provide deep pool habitat combined with overhead cover. Bankcovers not only provide adult trout with a superb habitat to feed from and evade predation, but they also stabilize streambanks from erosion. Streambanks located on outside bends showing signs of instability are ideal sites. Bankcovers are often constructed with pilings jettied into the substrate and then finished off by installing a set of stringer boards and deck boards to provide the overhead cover.

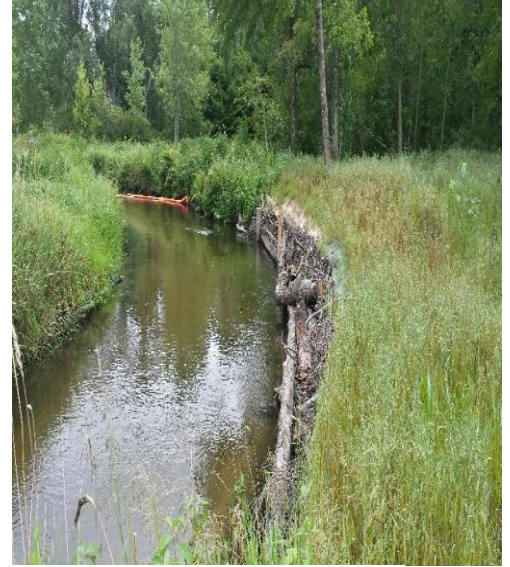
These complex, coarse, woody structures are constructed of whole trees and large limbs found within the stream corridor and are most often constructed in conjunction with trout stream fishability projects and trout habitat improvement projects. Log sill locations are most often in deep runs and pools at the outside streambank of meander bends in water exceeding two feet in depth. Diseased and storm-damaged trees that are creating navigability issues and streambank erosion issues are limbed into manageable pieces. The large butt sections are reoriented in a quartering downstream fashion and are anchored to either the streambank or streambed. The medium-sized material is placed on top of the largest materials, and brush and/or small limbs are placed on top of the medium material. Benefits include cost effectiveness, utilizing storm-damaged, dead or invasive tree species that are close to the river, providing complex woody cover habitat for adult fish, increasing the amount of anchoring substrate for aquatic invertebrates, allowing high water to flow over and through, which promotes sediment deposition within the structure, providing ideal conditions for instream aquatic vegetation growth and increasing streambank stability.

Log sill / Photo credit: Wisconsin DNR

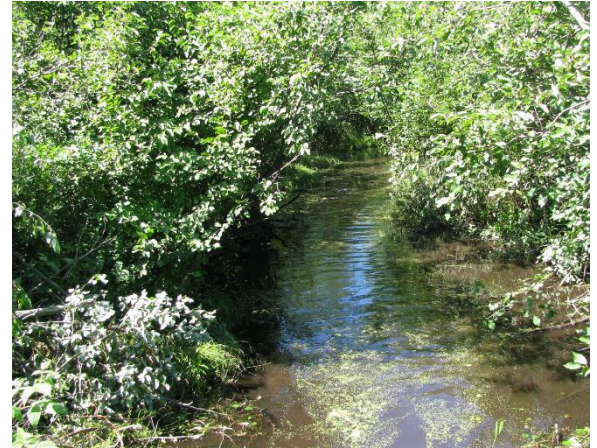
Tag Alder lined stream / Photo credit: Wisconsin DNR

Like fishability brushing but is designed to target tag alder stands. In some sections of streams, tag alder can become dense enough that it obstructs the stream. This can impede stream flow, causing water ponding, streambank erosion, sedimentation, and instream siltation, which can increase stream temperatures. In addition, tag alder brush can restrict recreational access to the stream. Tag alder brush on outside cut streambank bends is removed from the stream and immediate streambank. Other alder extending over half the channel width is also cut back to prevent future impediments to the stream. Brushing is often done by hand or chainsaws. On larger projects, a FECON (Florida Engineers in Construction) mulcher can be used on a track loader or excavator. Alder is often left in slack water areas as it still provides suitable habitat for trout and other species in these areas. Brushing helps maintain stream flow, prevents sediment deposition in the thalweg and aids in maintaining cold water temperatures. In addition, suppressing alder can allow improved access for recreation and help other preferable herbaceous and woody vegetation succeed.

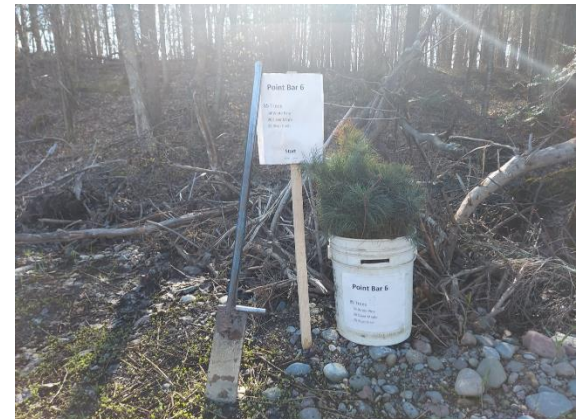
Tree planting point bars / Photo credit: Wisconsin DNR

Historically, many northern Wisconsin streams had stream corridors composed of mostly mature timber for vegetation cover. Presently, tag alder has not been succeeding to timber. To prompt the recruitment of trees in riparian corridors, trees are being planted. Tree plantings are often saplings consisting of white pine, tamarack, hemlock, maple and birch species. Trees are planted in high densities to combat deer browse loss. Trees are planted in random order to look as if they recruited naturally. The goals of tree plantings are streambank stabilization, suppressing tag alder growth, maintaining cold water by providing shade and recruiting wood to the stream in the future.

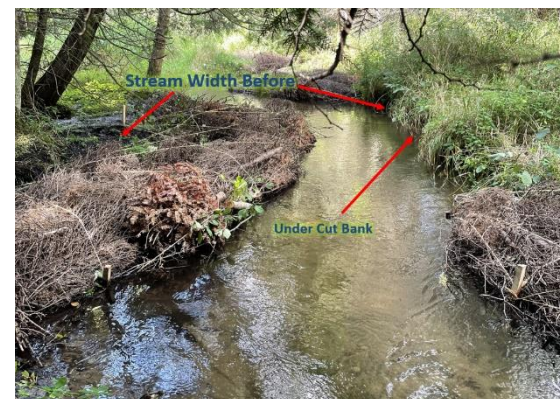
Brush bundles / Photo credit: Wisconsin DNR

Brush bundling or Brush Mattress is often done in wide and shallow sections of streams that have soft stream beds mainly composed of sand and/or silt. This technique utilizes cut materials from brushing or recycled Christmas trees to create bundles. These bundles are placed on the inside bend of a stream. The purpose of bundles is to narrow, deepen, concentrate stream flow and re-meander the stream channel. The bundles will capture soft sediments and, over time, create a new streambank that will eventually vegetate. This allows the stream to flush sand and silt, exposing spawning gravel and helping maintain cold water temperatures.

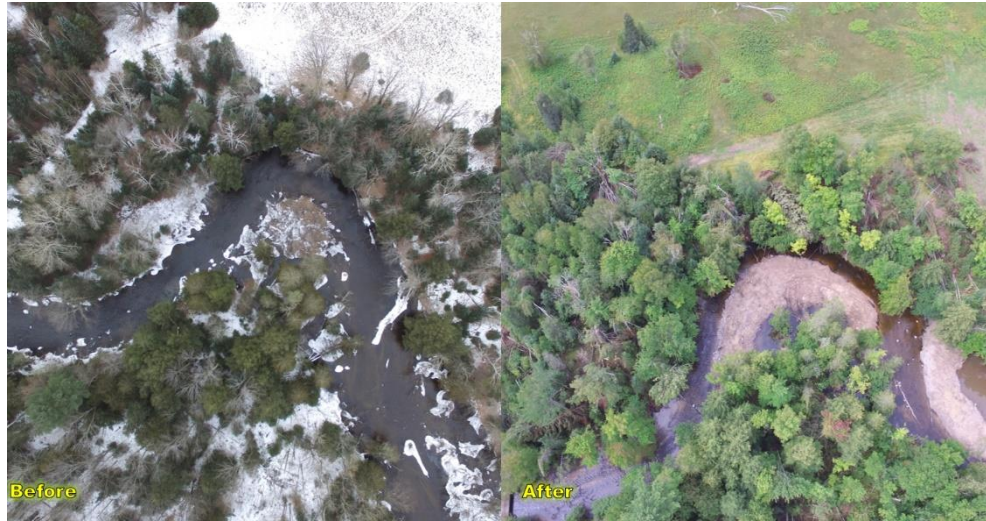
temperatures. Riffles are not removed as they are important natural hydraulic controls and spawning areas for trout. This helps to retain the natural hydraulic processes through the section of the stream. The channel shaping process results in increasing and improving the number of runs and pools while also narrowing the channel width of a section of stream. Large wood and rock additions are done along with channel shaping projects to increase the amount of complex habitat in the stream. Often, tree plantings and brushing are normal post-project vegetation management practices to help suppress tag alder growth and promote the recruitment of timber into the riparian corridor.

Channel shaping / Photo credit: Dave Curran

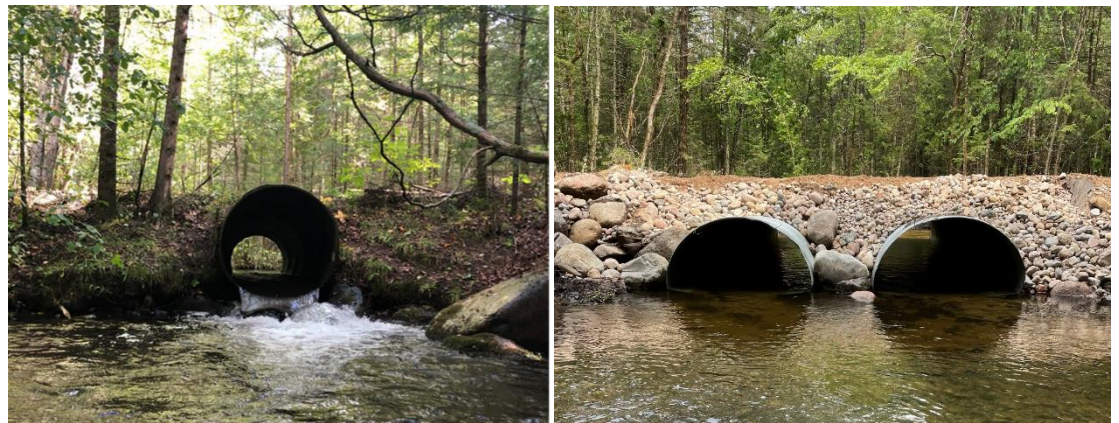
Stream crossings can often degrade the stream quality if constructed improperly. Crossings common in northern streams consist of bridges, culverts and fords. Improperly set and designed crossings can raise waterway elevations, which can lead to increased water temperatures, sedimentation above the crossing and a barrier for fish passage. In some locations, culverts are removed completely, converted to a ford crossing or replaced with properly designed and sized structures set at the correct elevation. Ford crossings are often improved by setting them at the correct substrate elevation to prevent increased water level elevation above the crossing.

Culvert before replacement (left photo) and after replacement (right photo). / Photo credit: Wisconsin DNR

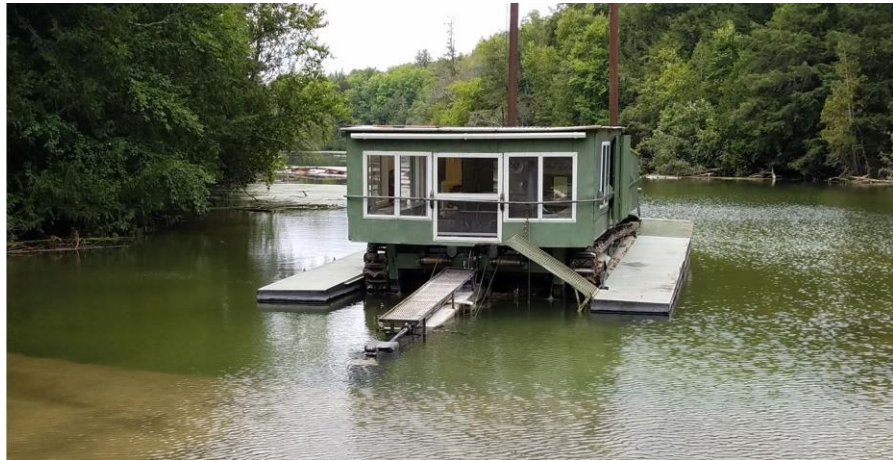
Wisconsin's largest concentration of spring ponds are found in Langlade County. Spring ponds age quickly because of the highly productive spring water feeding them. Calcium carbonate within the spring water precipitates, forming marl which is a substrate for periphyton growth. Over time, this causes these once flourishing cold water habitats to deteriorate with the accumulation of sediments, creating shallow habitats, limiting depth, warming cold water and rendering woody overhead cover unusable. This creates beds of aquatic vegetation and siltation of trout spawning areas. Other impairments of spring ponds are often the result of dammed water from manmade structures such as improperly set culverts, ford crossings and other impoundments. Restoring the natural hydrology of a spring pond is important before dredging. A floating hydraulic dredge is used to remove accumulated sediments and detritus materials from spring ponds. Soft sediments consisting mainly of a muck and marl slurry are pumped from the pond into a disposal area. Disposal areas are often an upland depression or berm area. The material in the disposal area will dewater, which will allow for reclamation of the area post dredging completion. Ponds are normally dredged to a maximum of twelve feet or mineral soil. Gravel spawning sites are improved by dredging and flushing sediments from them. Typically, 15-20% of the pond area will not be dredged. This provides a more diverse habitat for a variety of aquatic life such as young of the year trout, minnow species, amphibians, reptiles and benthic species. Exposed trees, logs and root wads found in the pond are repositioned after dredging is complete. The large wood provides complex habitat for trout. The dredging increases depth, which increases the living space for naturally reproducing trout.

Spring Pond Dredge - Anitgo / Photo credit: Wisconsin DNR

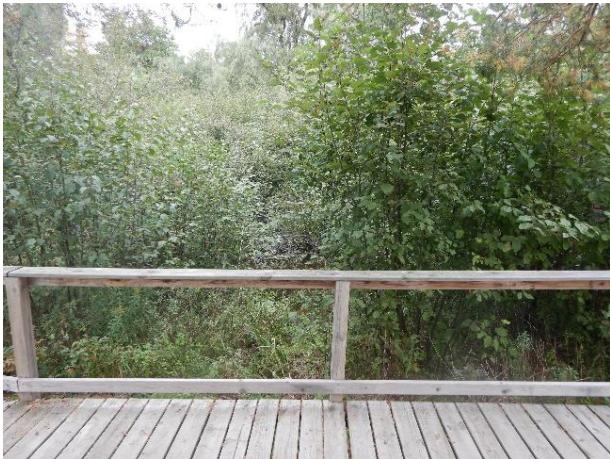
- **Fiscal Year:** 2019, 2020
- **Location:** 45.440415, -88.65745
- **Project Length:** 800 feet
- **Purpose:** Improve angler access and trout habitat
- **Stream Habitat Impairments:** Overgrown tag alders; reduced depth; limited trout cover
- **Target Species:** Brook and brown trout
- **Technique or Structure:** Brush bundle/mattresses; brush removal
- **Partners:** Town of Wabeno, Trout Unlimited

Before accessibility project. / Photo credit: Wisconsin DNR

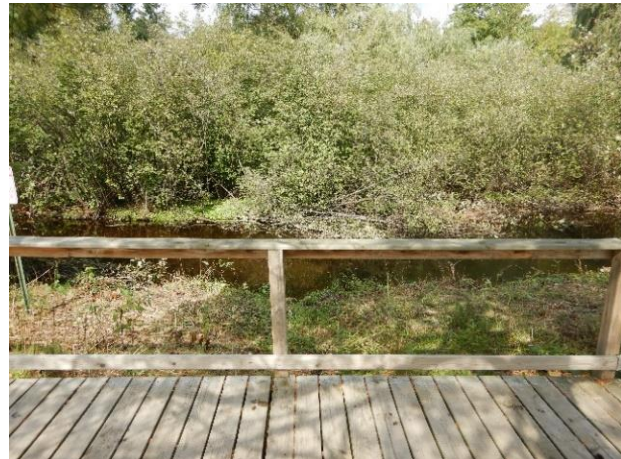
After accessibility project. / Photo credit: Wisconsin DNR

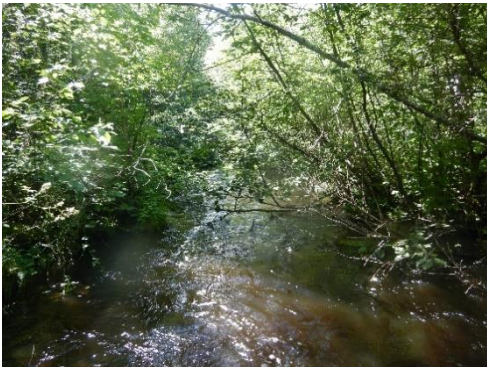
- **Fiscal Year:** 2019
- **Location:** 45.441226, -88.645044
- **Project Length:** 1,465 feet
- **Purpose:** Improve access and fishability; improve resting, refuge and feeding cover for brook and brown trout; reconnect the floodplain and improve fish passage
- **Stream Habitat Impairments:** Overgrown tag alder; mill dam constricting stream and disconnecting upstream and downstream portions of the floodplain; limited fish passage
- **Target Species:** Brook and brown trout
- **Technique or Structure:** Mill Dam removal; brush bundle/mattresses; material removal; brush removal; log sills; streambank re-establishment
- **Partners:** Wabeno Area School District, Trout Unlimited

*N. Br. Oconto River pre-brushing. /
Photo credit: Wisconsin DNR*

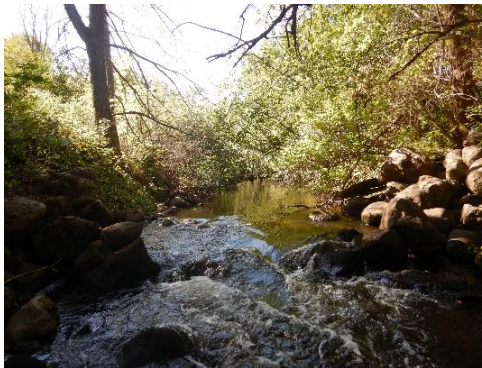
*Mill dam site before project. / Photo
credit: Wisconsin DNR*

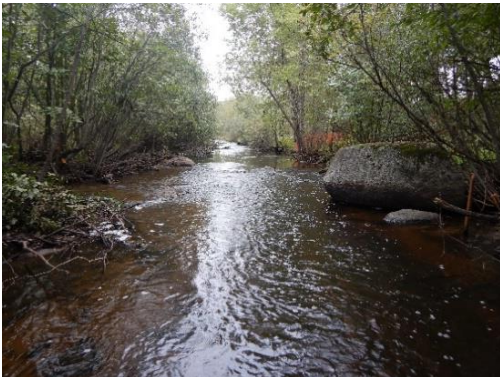
*N. Br. Oconto River post-brushing. /
Photo credit: Wisconsin DNR*

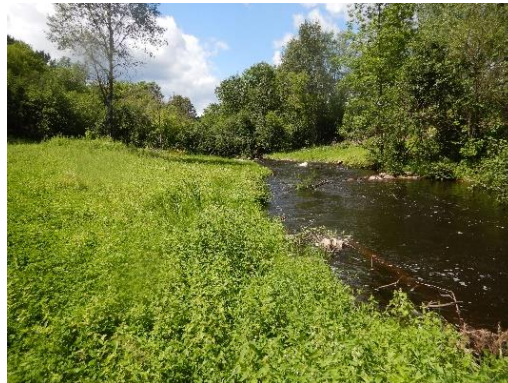
*Mill dam site after project. / Photo credit:
Wisconsin DNR*

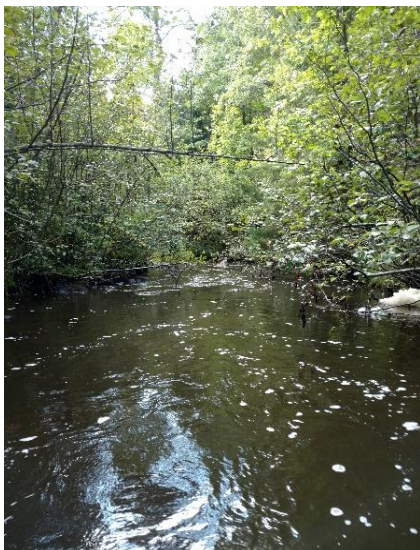
- **Fiscal Year:** 2019
- **Location:** 45.427129, -88.204698
- **Project Length:** 1,560 feet
- **Purpose:** Re-establish natural streambanks; reconnect stream to floodway; remove degraded structures; reduce erosion; improve angler access and fishability
- **Stream Habitat Impairments:** No floodplain connectivity; Bank covers too numerous; constricted stream channel; lack of sediment transport; sand deposits on top of streambank; improperly installed structures causing adverse erosional issues on opposite banks as well as looking unnatural
- **Target Species:** Brook trout
- **Technique or Structure:** Material removal; brush removal; streambank re-establishment

*Eagle Creek pre-brushing. /
Photo credit: Wisconsin DNR*

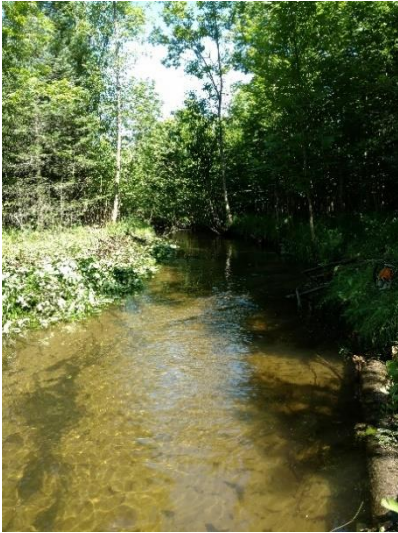
N. Br. Beaver Creek post-brushing./ Photo credit: Wisconsin DNR

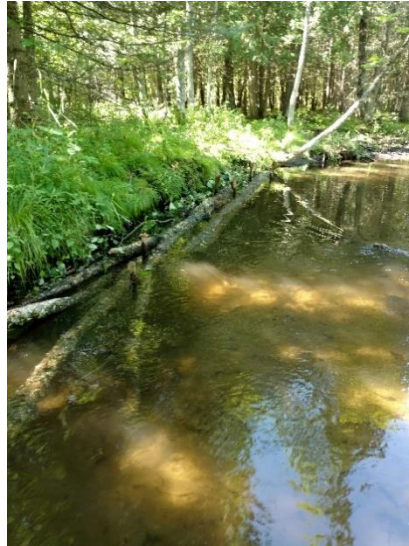
Log sill installed on N. Br. Beaver Creek./ Photo credit: Wisconsin DNR

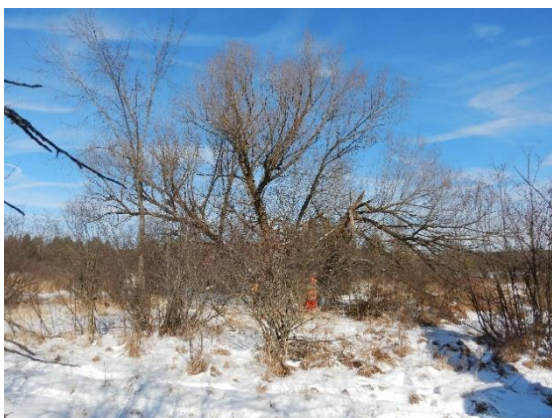
Angler path after removal of large willow tree along Chaffee Creek. / Photo credit: Wisconsin DNR

- **Fiscal Year:** 2021
- **Location:** 43.9598, -89.4024
- **Project Length:** 3,200 feet
- **Purpose:** Improve access and fishability
- **Stream Habitat Impairments:** Overgrowth of invasive woody vegetation
- **Target Species:** Brown trout
- **Technique or Structure:** Fishability brushing, willow tree removal, angler paths and exotic vegetation removal

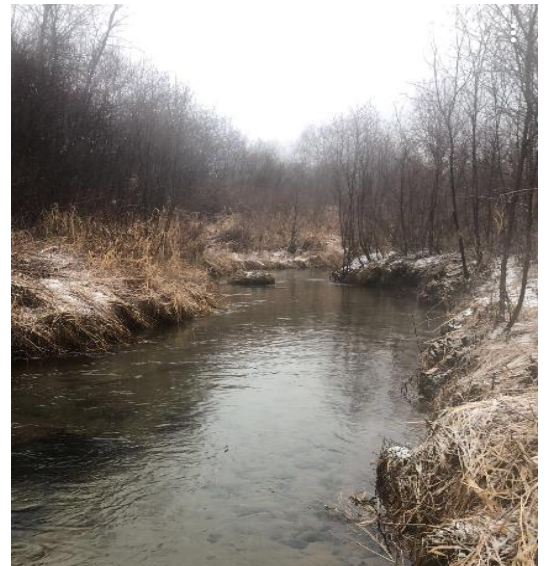
After Chaffee Creek brushing project, 2020. / Photo credit: Wisconsin DNR

- **Fiscal Year:** 2021
- **Location:** 43.98137, -89.49247
- **Project Length:** 2,500 feet
- **Purpose:** Improve access and fishability
- **Stream Habitat Impairments:** Overgrowth of invasive exotic woody vegetation (buckthorn and honeysuckle)
- **Target Species:** Brown trout
- **Technique or Structure:** Fishability brushing; angler paths; exotic vegetation removal

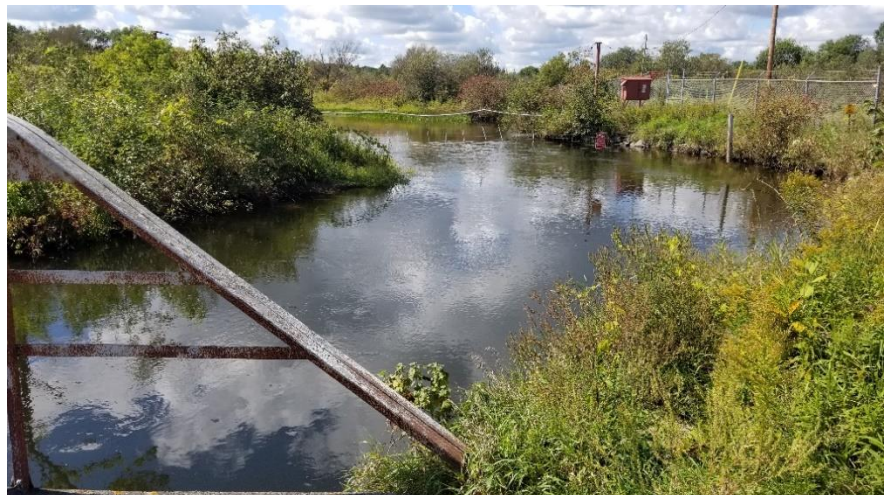
- **Fiscal Year:** 2021
- **Location:** 43.9065, -89.2776
- **Project Length:** 100 feet
- **Purpose:** Preventative removal of hazardous willow trees from around the electric fish barrier
- **Stream Habitat Impairments:** An electric fish barrier was installed in 1964 to prevent rough fish and northern pike migration from the Germania Marsh Wildlife Area upstream into classified trout water of the Mecan River.
- **Target Species:** Brown trout
- **Technique or Structure:** Willow tree removal

Electric fish barrier on Mecan River. / Photo credit: Wisconsin DNR

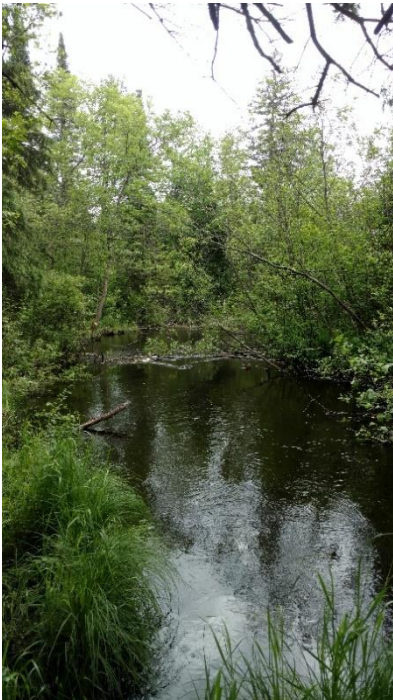
- **Fiscal Year:** 2019,2020
- **Location:** 45.171234, -88.618691
- **Project Length:** 5,200 feet
- **Purpose:** Increase access and fishability for the handicapped boardwalk and throughout the USFS property; increase resting, refuge and feeding cover.
- **Stream Habitat Impairments:** Storm damage and dense tag alder growth; reduced access to handicapped accessible fishing platforms; widened and shallow stream channel
- **Target Species:** Brook and brown trout
- **Technique or Structure:** Brush bundle/mattresses, log/brush/rock shelters and brush removal
- **Partners:** Oconto River Trout Unlimited, Wolf River Trout Unlimited, Green Bay Trout Unlimited and Marinette Trout Unlimited

*S. Br. Oconto River pre-brushing. /
Photo credit: Wisconsin DNR*

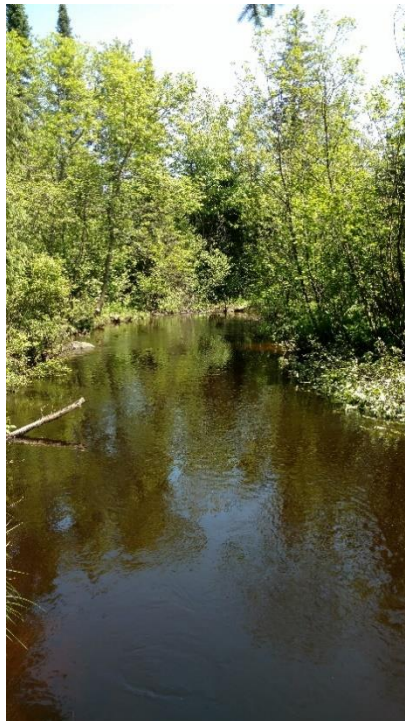
*S. Br. Oconto River post-brushing. /
Photo credit: Wisconsin DNR*

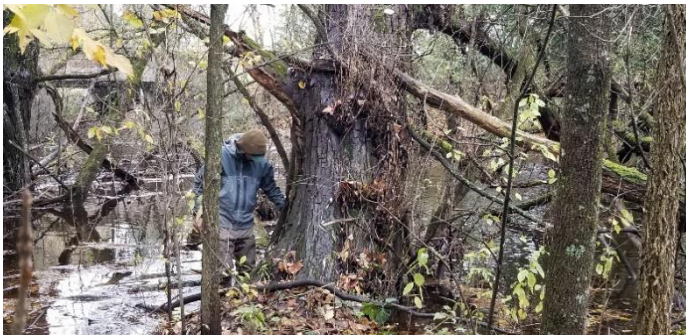
Wild Rose crew member sizing up large willow tree to be removed. / Photo credit: Wisconsin DNR

- **Fiscal Year:** 2020
- **Location:** 45.02194, -88.41638
- **Project Length:** 3,300 feet
- **Purpose:** Improve angler access, navigation and fishability
- **Stream Habitat Impairments:** massive trees blocking stream channel
- **Target Species:** Brook and brown trout
- **Technique or Structure:** Exotic vegetation removal

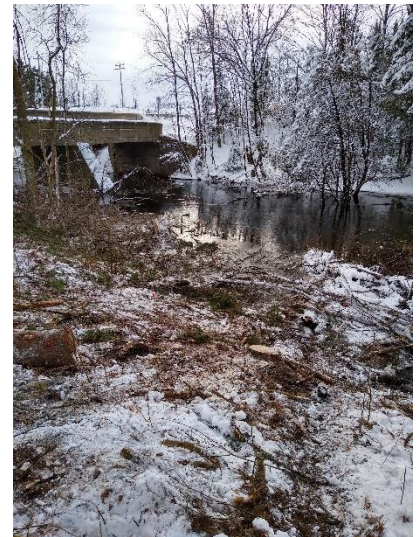
Riparian corridor post brush removal. / Photo credit: Wisconsin DNR

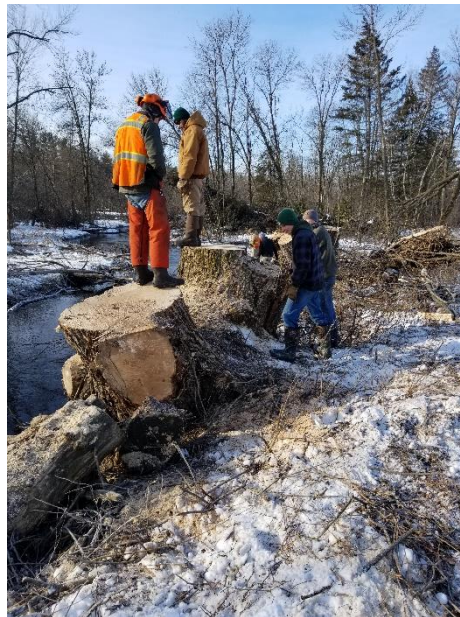
Post brush removal on Peterson Creek, 2020. / Photo credit: Wisconsin DNR

- **Fiscal Year:** 2020
- **Location:** 44.43501, -89.1713
- **Project Length:** 1,300 feet
- **Purpose:** Improve angler access and fishability; reduce streambank erosion.
- **Stream Habitat Impairments:** Overgrown, downed woody vegetation; impaired angler access
- **Target Species:** Brown trout
- **Technique or Structure:** Brush removal; exotic vegetation removal

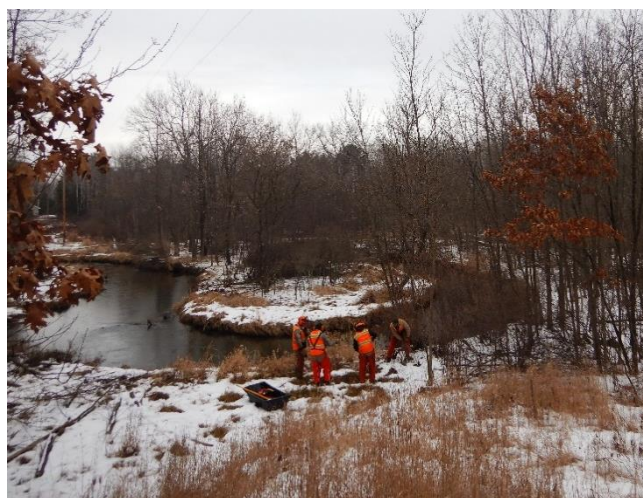
Wild Rose crew brushing Radley Creek. / Photo credit: Wisconsin DNR

- **Fiscal Year:** 2019
- **Location:** 44.29614, -89.15303
- **Project Length:** 3,500 feet
- **Purpose:** Improve angler access and fishability
- **Stream Habitat Impairments:** Dense woody vegetation
- **Target Species:** Brown trout
- **Technique or Structure:** Brush removal; angler paths

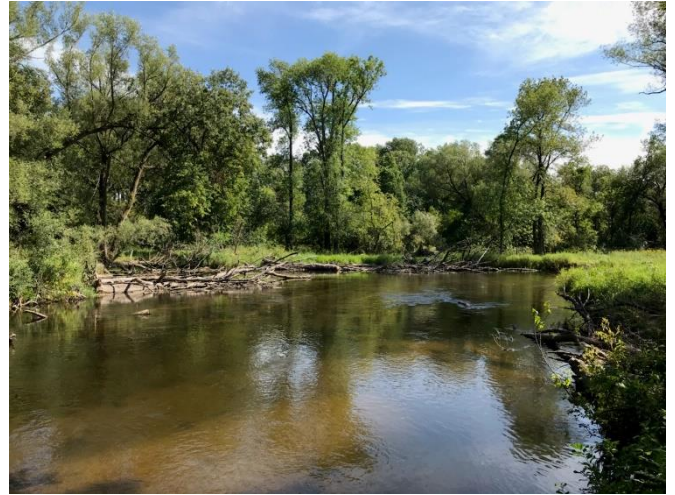
Log sills installed on Waupaca River. / Photo credit: Wisconsin DNR

- **Fiscal Year:** 2019
- **Location:** 44.3293, -89.2137
- **Project Length:** 1,600 feet
- **Purpose:** Stabilize streambanks; improve trout angling access, trout habitats, canoe access and stream crossing
- **Stream Habitat Impairments:** Destabilized streambanks; impaired navigation and angling; invasive exotic species of woody vegetation
- **Target Species:** Brown trout
- **Technique or Structure:** Stream crossing, beaver dam removal; brush removal; log sills; exotic vegetation removal
- **Partners:** City of Waupaca (Partnership)

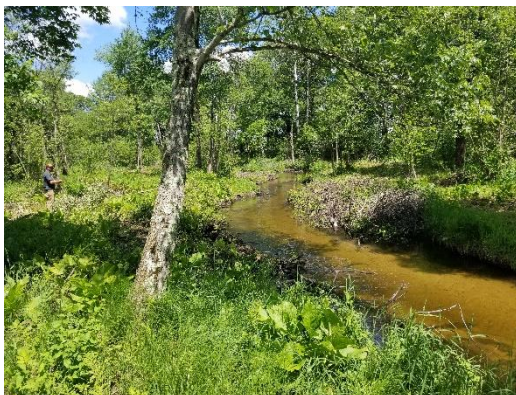
Brush bundles, log sills and fishability brushing completed on Bird Creek. / Photo credit: Wisconsin DNR

- **Fiscal Year:** 2019, 2020, 2021
- **Location:** 44.07193, -89.30361
- **Project Length:** 2,300 feet
- **Purpose:** Improve access; improve instream trout habitat
- **Stream Habitat Impairments:** Reduced stream velocity; accumulation of fine sediments
- **Target Species:** Brook and brown trout
- **Technique or Structure:** Brush bundle/mattresses; brush removal; log sills; exotic vegetation removal; riffles
- **Partners:** City of Wautoma, Wautoma Highschool, Wautoma Citizens, Central Wisconsin Chapter of Trout Unlimited, Fox Valley Chapter of Trout Unlimited, Frank Hornberg Chapter of Trout Unlimited, Shaw-Paca Chapter of Trout Unlimited and Trout Unlimited Youth Camp

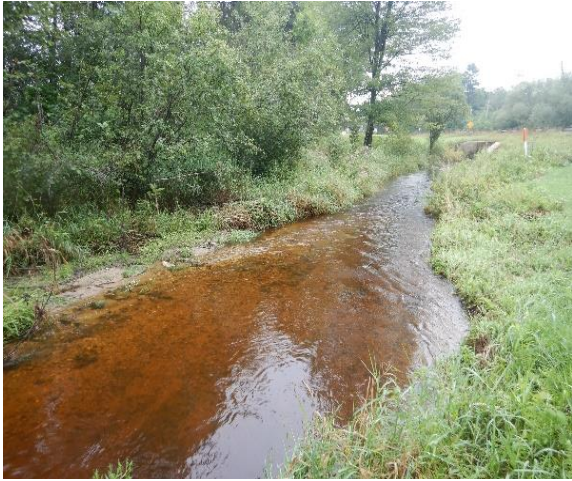
*Riffle complex, post-installation on Bird Creek.
/ Photo credit: Wisconsin DNR*

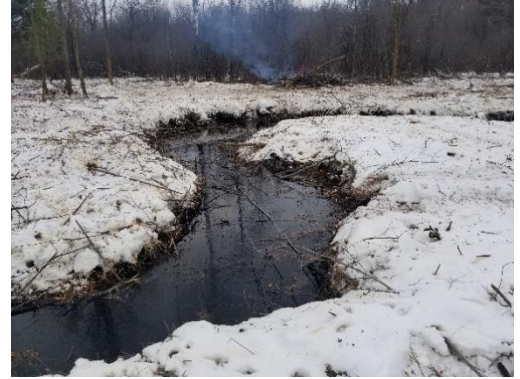
Post brush removal on Kaminski Creek. / Photo credit: Wisconsin DNR

- **Fiscal Year:** 2020
- **Location:** 44.18304, -89.2016
- **Project Length:** 2,400 feet
- **Purpose:** Improve access for anglers
- **Stream Habitat Impairments:** Overgrown woody vegetation; impaired angler access
- **Target Species:** Brook trout
- **Technique or Structure:** Brush removal

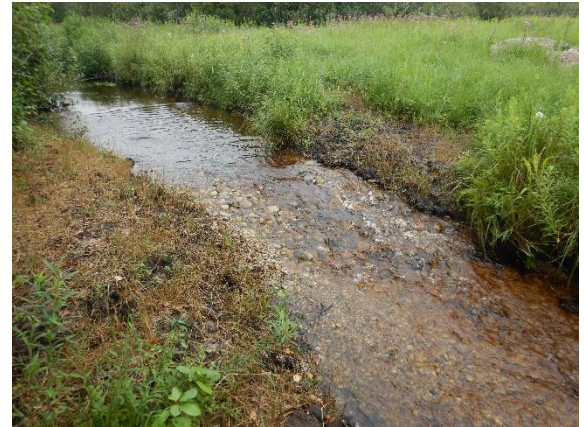
Riffle installation on Kaminski Creek. / Photo credit: Wisconsin DNR

- **Fiscal Year:** 2021
- **Location:** 44.18266, -89.19492
- **Project Length:** 1,500 feet
- **Purpose:** Improve instream habitat, fishability and access
- **Stream Habitat Impairments:** Overgrown woody vegetation; impaired angler access
- **Target Species:** Brook trout
- **Technique or Structure:** Fishability brushing; riffles; angler paths; exotic vegetation removal

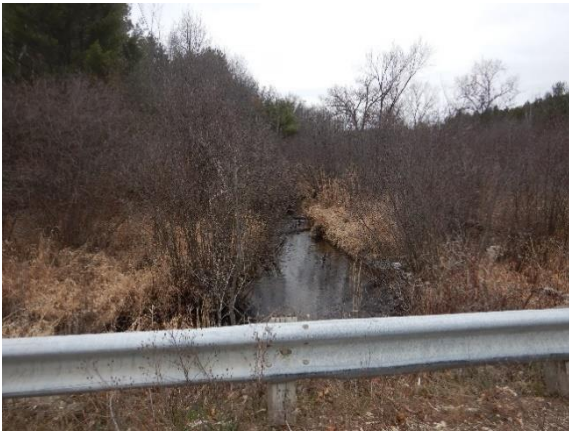
Little Pine Creek pre brush removal. / Photo credit: Wisconsin DNR

- **Fiscal Year:** 2021
- **Location:** 43.9966, -89.34026
- **Project Length:** 2,200 feet
- **Purpose:** Improve access and fishability
- **Stream Habitat Impairments:** Overgrown native shrubs; invasive exotic woody vegetation; storm damaged trees
- **Target Species:** Brook trout
- **Technique or Structure:** Fishability brushing; angler paths; exotic vegetation removal

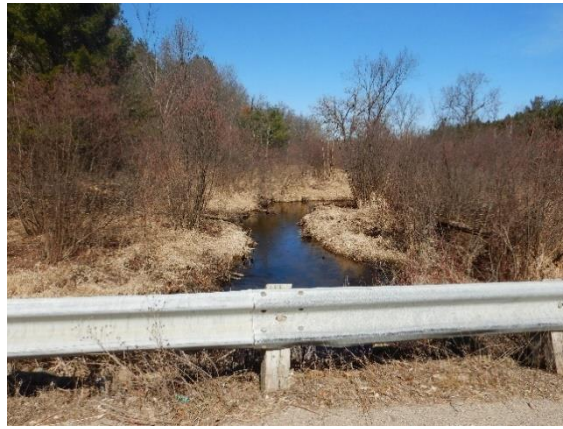
Little Pine Creek post brush removal. / Photo credit: Wisconsin DNR

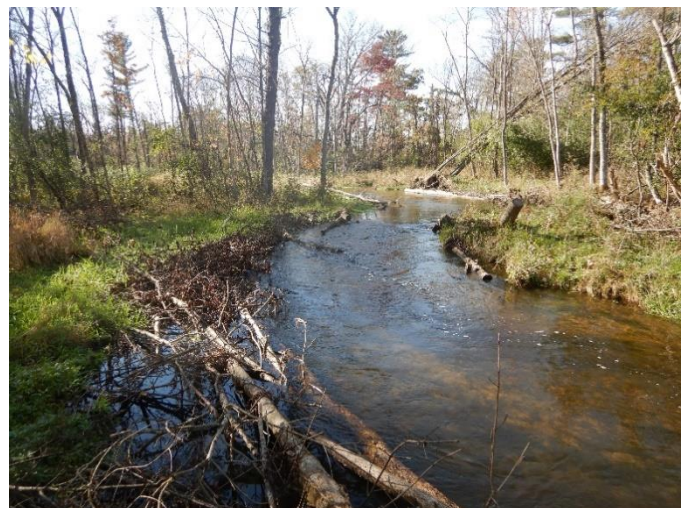
Log sill installation on the Pine River. / Photo credit: Wisconsin DNR

- **Fiscal Year:** 2019
- **Location:** 44.18514, -89.16148
- **Project Length:** 3,700 feet
- **Purpose:** Improve angler access and fishability, complex trout habitats and channelized stream segments
- **Stream Habitat Impairments:** Invasive exotic woody vegetation (glossy buckthorn); instability to streambanks; a loss of natural wood recruitment instream; a loss of species diversity (flora and fauna) within the riparian corridor; reduced recreational access through the river; widened stream channel
- **Target Species:** Brook and brown trout
- **Technique or Structure:** Brush bundle/mattresses; overhead bank cover; brush removal; log sills; angler paths; exotic vegetation removal
- **Partners:** Central Wisconsin Chapter of Trout Unlimited and Fox Valley Chapter of Trout Unlimited

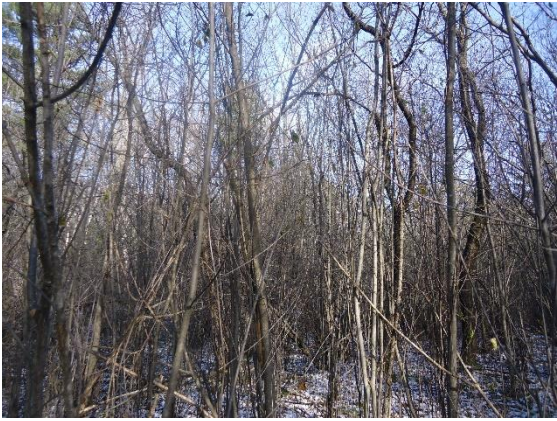
Pre-buckthorn removal on South Fork of the White River. / Photo credit: Wisconsin DNR

- **Fiscal Year:** 2019, 2020, 2021
- **Location:** 46.45452, -91.2842
- **Project Length:** 5,000 feet
- **Purpose:** Removal of dense vegetated areas of glossy buckthorn (*Rhamnus frangula*)
- **Stream Habitat Impairments:** Riparian corridors of densely vegetated by the exotic shrub glossy buckthorn
- **Target Species:** Brook and brown trout
- **Technique or Structure:** Tree cover; brush removal; angler paths; exotic vegetation removal
- **Partners:** 4Control Inc

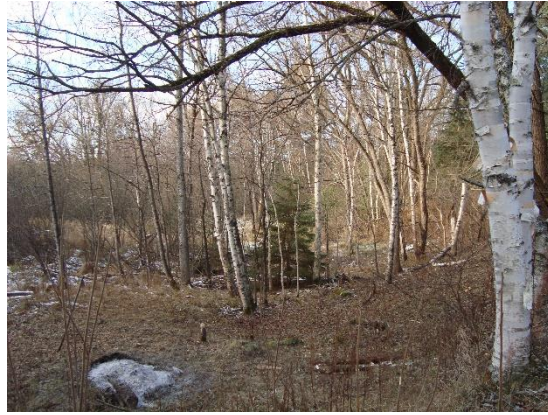
Post-buckthorn removal on South Fork of the White River. / Photo credit: Wisconsin DNR
