Wisconsin Department of Natural Resources
Inland Waters Trout Stamp Expenditure Report
Fiscal Years 2019-2021

Bureau of Fisheries Management
Administrative Report No. 102

This document summarizes expenditures of the Inland Waters Trout Stamp (IWTS) Program by the Bureau of Fisheries Management for fiscal years (FY) 2019 (July 1, 2018 – June 30, 2019), 2020 (July 1, 2019 – June 30, 2020) and 2021 (July 1, 2020 – June 30, 2021).

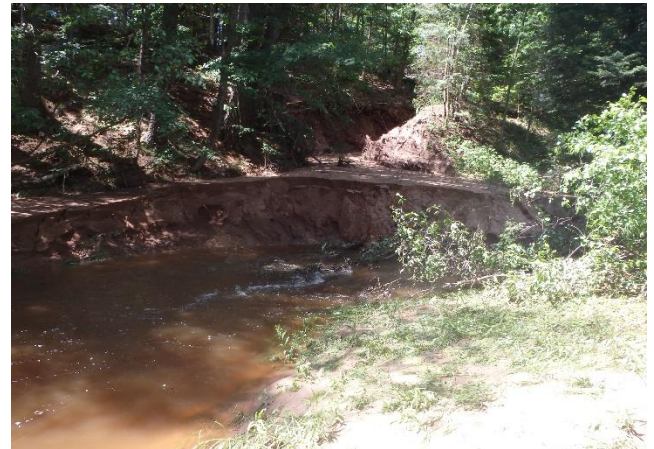
- **Fiscal Year:** 2020, 2021
- **Project Length:** 400 feet
- **Location:** 46.45191, -91.28900
- **Purpose:** Stabilize the streambank, which had washed out from flood events.
- **Stream Habitat Impairments:** Sedimentation of important spawning area; buried and irreparably damaged two existing boom covers; stream channel artificially wide and shallow.
- **Target Species:** Brook and brown trout
- **Technique or Structure:** Streambank shaping; rip rap; seeding
- **Partners:** DNR - Forestry

Eroding hillside and streambank on South Fork of the White River. / Photo credit: Wisconsin DNR

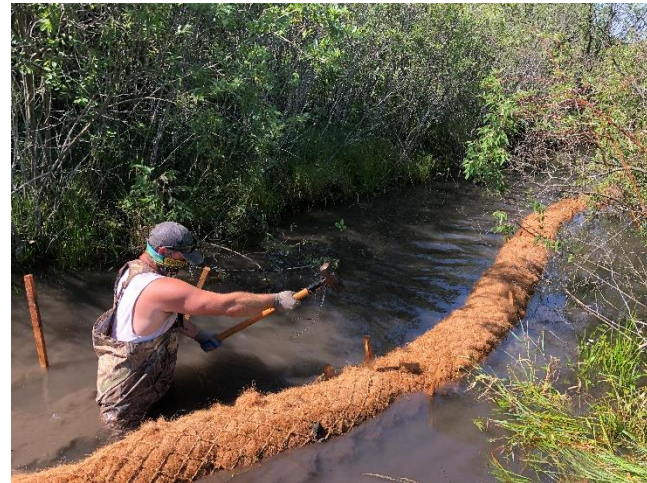
- **Fiscal Year:** 2021
- **Location:** 42.7939, -88.2512
- **Project Length:** 650 feet
- **Purpose:** Narrow stream channel to mobilize soft sediment, concentrate stream flow, maintain cold water conditions produced in the headwaters, and remove multiple fish passage impediments.
- **Stream Habitat Impairments:** Braiding; siltation; warming; lack of natural morphology and flow regime; fish passage impediments
- **Target Species:** Brook trout
- **Technique or Structure:** Brush bundle/mattresses; beaver dam removal; beaver removal; migration barriers; coconut fiber roll; brush removal

Installation of coconut fiber roll on Tichigan Creek to aid in narrowing stream channel. / Photo credit: Wisconsin DNR

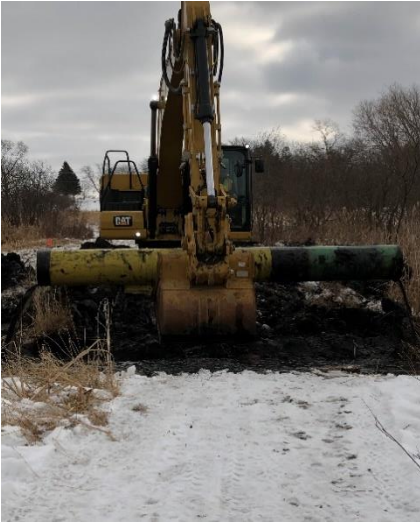
- **Fiscal Year:** 2021
- **Location:** 42.7974, -88.2497
- **Project Length:** 30 feet
- **Purpose:** Replace a failing tin whistle with an appropriately sized culvert
- **Stream Habitat Impairments:** Sedimentation and warming
- **Target Species:** Brook trout
- **Technique or Structure:** Stream crossing replacement

Removal of failing tin whistle on Tichigan Creek. / Photo credit: Wisconsin DNR

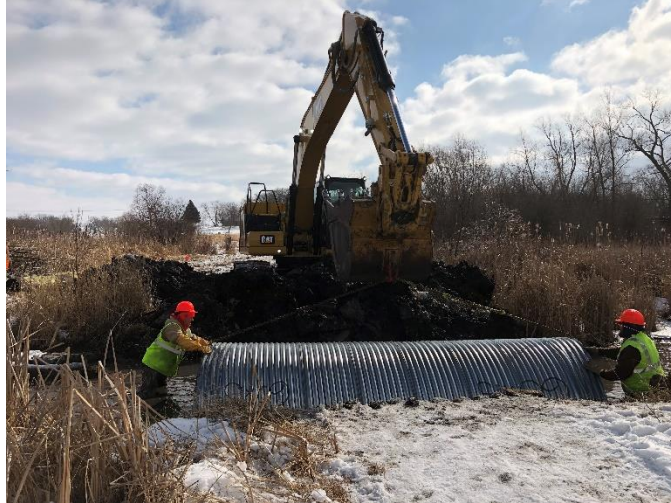
Installation of new culvert on Tichigan Creek. / Photo credit: Wisconsin DNR

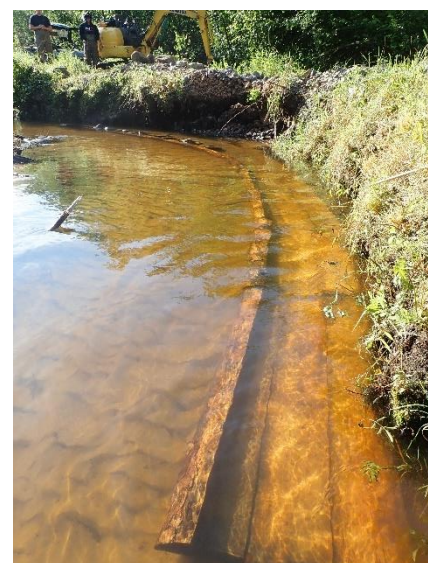
Installation of jetted bank cover on Fordham Creek. / Photo credit: Wisconsin DNR

- **Fiscal Year:** 2019
- **Location:** 43.97700, -89.71581
- **Project Length:** 1,500 feet
- **Purpose:** Increase the number of adult brown trout and rainbow trout; establish grass vegetation and stabilize streambank; decrease mean stream width and increase mean stream depth
- **Stream Habitat Impairments:** Steep eroded outside bends; very little overhead cover; shifting sand substrate; dense tag alder; shallow stream channel
- **Target Species:** Brook and brown trout
- **Technique or Structure:** Brush bundle/mattresses; overhead bank cover; trees/root wads; plunge pools; log sills
- **Partners:** City of Stevens Point, Roger Springman and Dwight Mueller

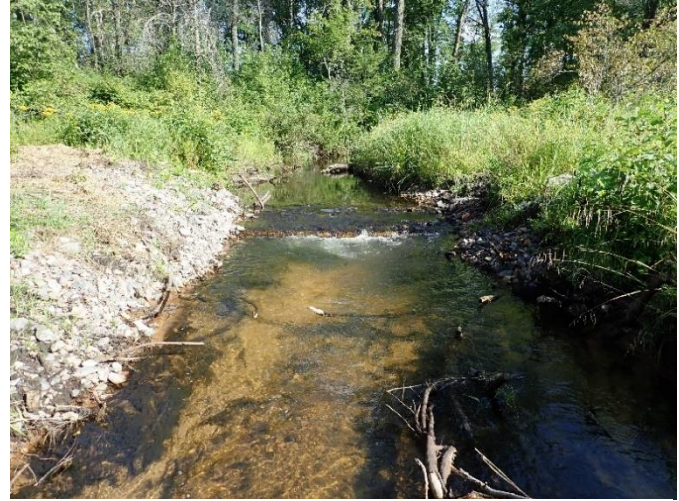
Plunge pool installed on Fordham Creek. / Photo credit: Wisconsin DNR

- **Fiscal Year:** 2021
- **Location:** 43.98462, -89.74181
- **Project Length:** 3,122 feet
- **Purpose:** Improve habitat for trout on a newly acquired streambank easement; narrow and deepen the stream channel; improve overhead cover for fish
- **Stream Habitat Impairments:** Widened and shallow stream channel; dense tag alder and dead ash stands
- **Target Species:** Brook and brown trout
- **Technique or Structure:** LUNKERS; plunge pools; tree cover; log, root wad and boulder revetments; log sills; tree removal
- **Partners:** Andrew Kolff

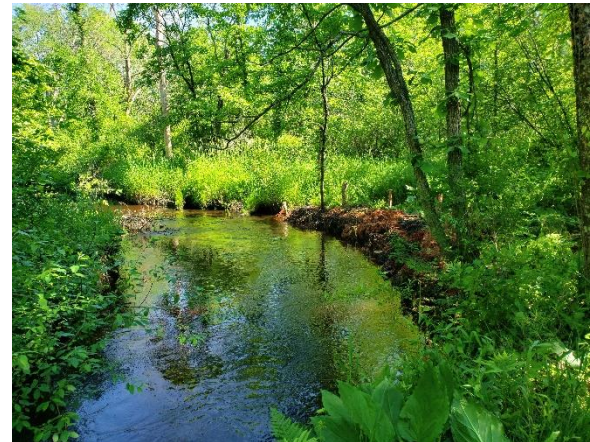
Brush bundles/mattresses installed on Little Roche-A-Cri Creek. / Photo credit: Wisconsin DNR

- **Fiscal Year:** 2019
- **Location:** 43.9968, -89.75181
- **Project Length:** 2,700 feet
- **Purpose:** The purpose of the project is to install overhead cover for trout, increase the number of brook trout, increase stream depth and establish grass cover along the streambank.
- **Stream Habitat Impairments:** Widened and shallow stream channel; dense dead ash stand
- **Target Species:** Brook trout
- **Technique or Structure:** Brush bundle/mattresses
- **Partners:** City of Stevens Point

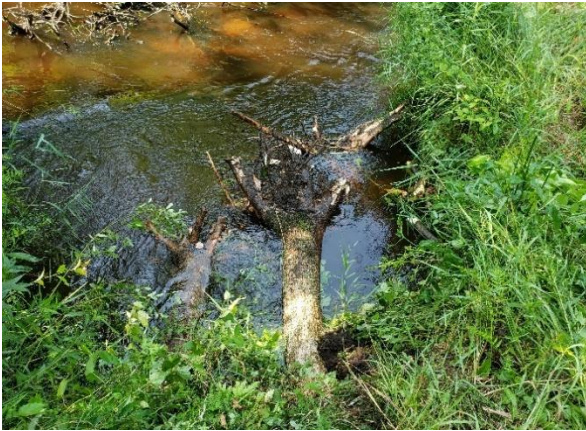
Root wad structures installed on sill installed on Little Roche-A-Cri Creek. / Photo credit: Wisconsin DNR

- **Fiscal Year:** 2020, 2021
- **Location:**
- **Project Length:** 2,700 feet
- **Purpose:** Improve the overhead cover; decrease streambank erosion
- **Stream Habitat Impairments:** Streambank erosion; widening of stream channel; limited overhead cover
- **Target Species:** Brook trout
- **Technique or Structure:** Brush bundle/mattresses; LUNKERS; trees/root wads; plunge pools; log sills

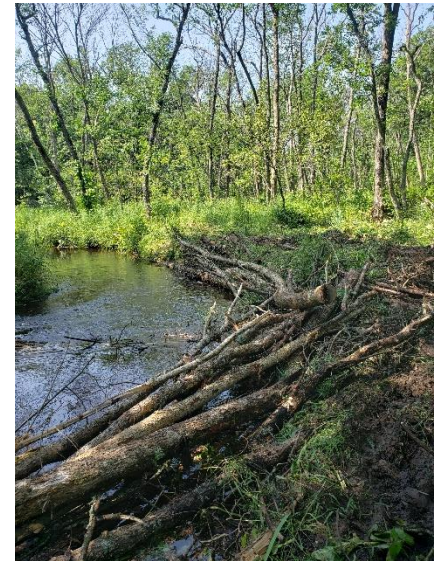
Log sill installed on Little Roche-A-Cri Creek. / Photo credit: Wisconsin DNR

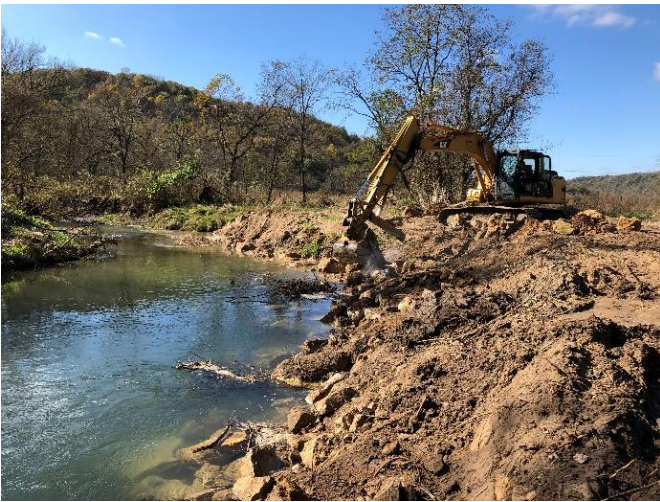
Rush Creek streambank being stabilized with logs and root wads incorporated into the rock. / Photo credit: Wisconsin DNR

- **Fiscal Year:** 2021
- **Location:** 43.39738, -91.08757
- **Project Length:** 350 feet
- **Purpose:** Connect stream to floodway; stabilize streambanks; establish riparian vegetation
- **Stream Habitat Impairments:** Streambank erosion
- **Target Species:** Brown trout
- **Technique or Structure:** Streambank sloping; material removal; stream crossing; streambank shaping and planting

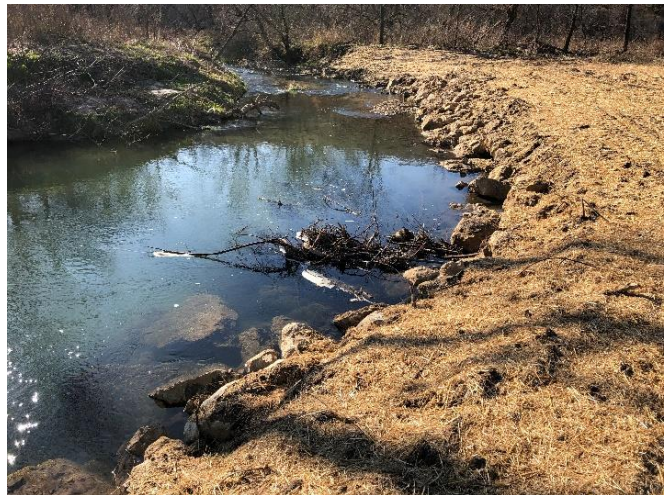
Same streambank completed with seed and mulch. / Photo credit: Wisconsin DNR

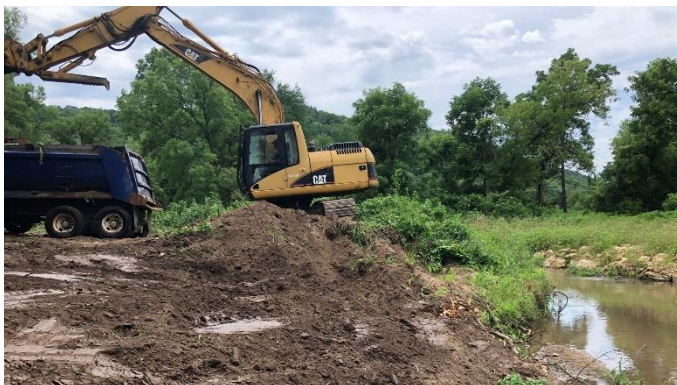
Left photo - Excavator removing deposition from the inside point to connect Rush Creek to floodplain. / Photo credit: Wisconsin DNR

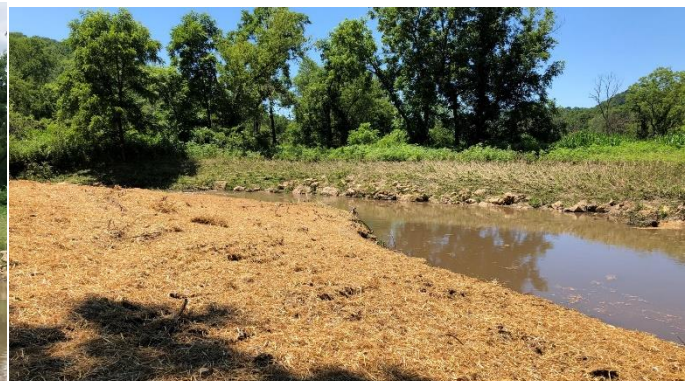
Right photo - The same inside point after deposition is removed and then seeded and mulched. Notice the opposite side streambank with the vegetation laid down from the high-water event. / Photo credit: Wisconsin DNR

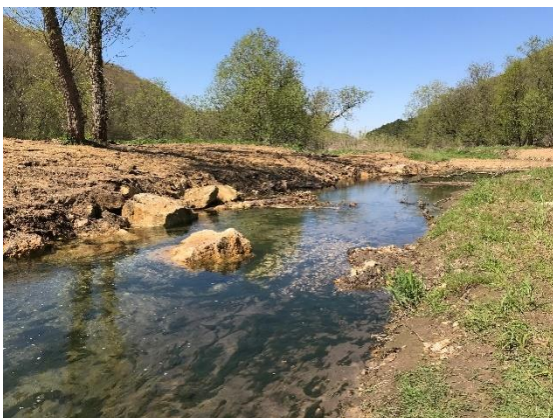
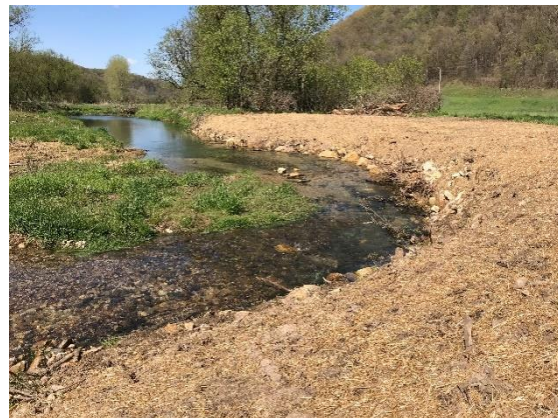
Streambanks along Sugar Creek immediately following completion of habitat work. Streambanks were sloped, seeded and stabilized with rock and root wads. / Photo credit: Wisconsin DNR

- **Fiscal Year:** 2019
- **Location:** 43.38046, -90.99368
- **Project Length:** 405 feet
- **Purpose:** Stabilize the eroding streambanks; improve habitat for trout and other aquatic species
- **Stream Habitat Impairments:** Eroding streambanks; limited cover for trout.
- **Target Species:** Brown trout
- **Technique or Structure:** Streambank sloping; trees/root wads; rip rap; instream boulder; material removal; streambank shaping and planting
- **Partners:** Prairie Rod and Gun Club, Crawford County LCD

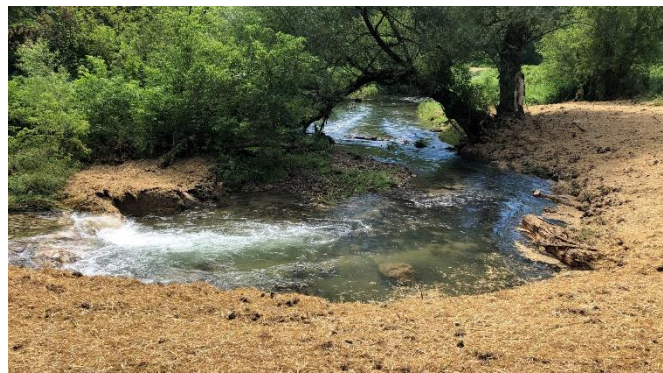
Recently installed rock weir with plunge pool creating cover for Tainter Creek brown trout. Streambanks have been mulched and seeded. / Photo credit: Wisconsin DNR

- **Fiscal Year:** 2020, 2021
- **Location:** 43.42161, -90.89321
- **Project Length:** 745 feet
- **Purpose:** Stabilize three eroding streambanks and improve trout habitat by installing three rock weirs
- **Stream Habitat Impairments:** Eroding unstable streambanks; widened and shallow stream channel.
- **Target Species:** Brown trout
- **Technique or Structure:** Streambank sloping; rip rap; boulder retard; weir; plunge pools; log/brush/rock shelters; ERO; bank shaping and planting

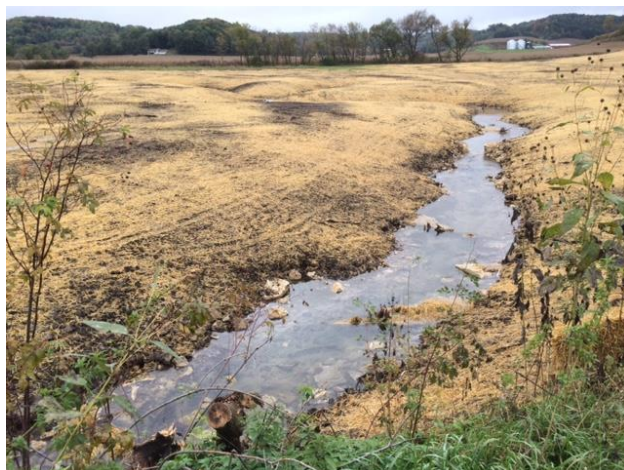
Hay Creek (3)

Hay Creek project area post habitat work. Streambanks were sloped and seeded to reconnect the floodplain with boulder clusters for instream habitat. / Photo credit: Wisconsin DNR

- **Fiscal Year:** 2019
- **Location:** 44.93514, -92.06555
- **Project Length:** 3,281 feet
- **Purpose:** Trout habitat enhancement and streambank stabilization on a public fishing easement; flush fine sediment; improve spawning habitat
- **Stream Habitat Impairments:** Limited trout habitat; streambank erosion.
- **Target Species:** Brook trout
- **Technique or Structure:** Trees/root wads; rip rap; instream boulders; stream crossing; streambank stabilization fabric; native seed planting
- **Partners:** Trout and Salmon Grant, Covia, Wisconsin Clear Waters TU, Kiap-TU-Wish T.U., USFWS and NRCS

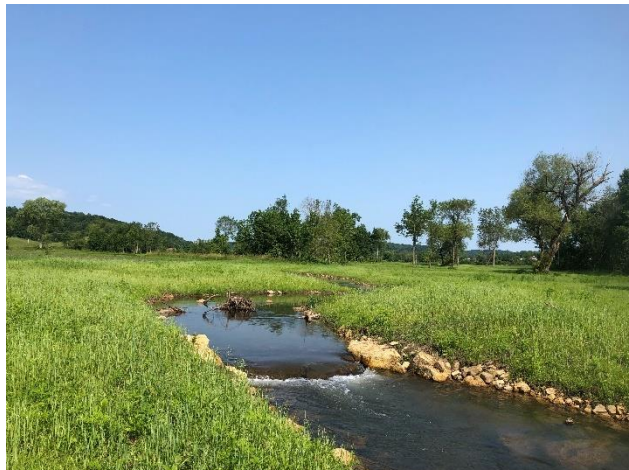
Wilson Creek (5)

Wilson Creek post habitat project. Plunge pool installation with root wad upstream. / Photo credit: Wisconsin DNR

- **Fiscal Year:** 2019
- **Location:** 44.95998, -92.06564
- **Project Length:** 4,740 feet
- **Purpose:** Improve instream habitat; increase brook trout abundance and size structure; remove nuisance trees to stabilize streambanks; and improve angler access to the stream corridor
- **Stream Habitat Impairments:** Limited trout habitat; severe streambank erosion; sedimentation; dense box elder tree stand
- **Target Species:** Brook and brown trout
- **Technique or Structure:** Trees/root wads; rip rap; stream crossing; plunge pools; boulder clusters
- **Partners:** NRCS, Wisconsin Clear Waters Trout Unlimited and Dunn County

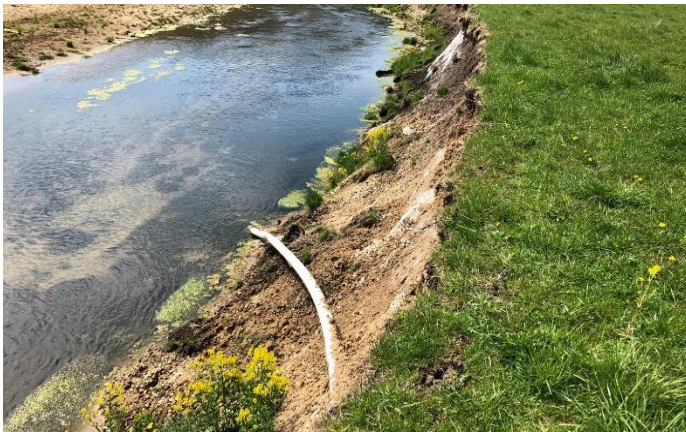
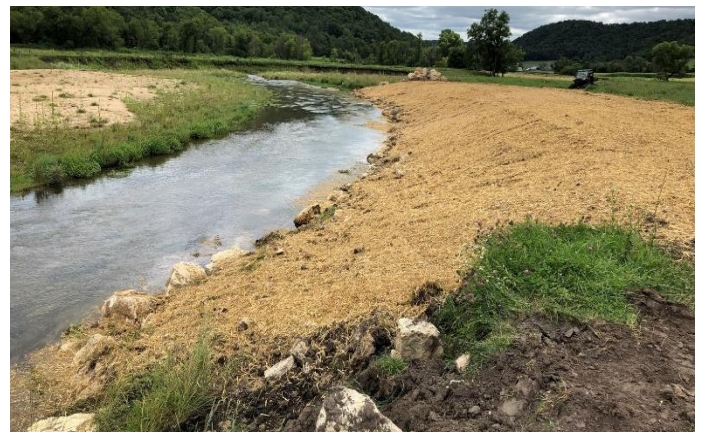
- **Fiscal Year:** 2021
- **Location:** 43.74805, -90.96157
- **Project Length:** 415 feet
- **Purpose:** Stabilize streambank; improve trout habitat; repair septic field
- **Stream Habitat Impairments:** Unstable streambanks; exposed septic field; limited habitat
- **Target Species:** Brown trout
- **Technique or Structure:** Streambank sloping; rip rap; boulder retard; weir; grade control measures; streambank shaping and planting

Left photo - Eroded streambank on Coon Creek with exposed drain field. / Photo credit: Wisconsin DNR

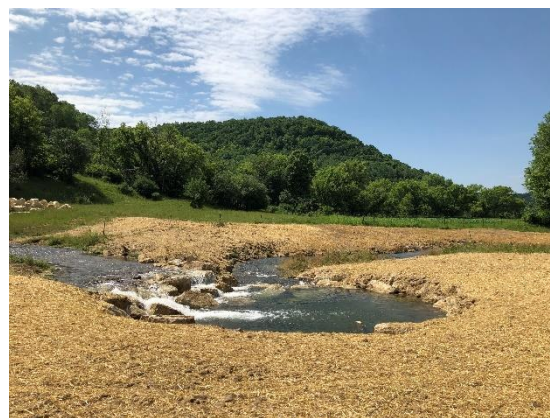
- **Fiscal Year:** 2021
- **Location:** 43.75091, -90.95947
- **Project Length:** 2,280 feet
- **Justification and Purpose:** Stabilize eroding streambanks; restore instream habitat damaged by flood events
- **Stream Habitat Impairments:** Unstable streambanks; limited instream habitat for trout
- **Target Species:** Brown trout
- **Technique or Structure:** Bank sloping; trees/root wads; rip rap; plunge pools; channel shaping; grade control measures; bank shaping and planting

Recently installed rock weir with plunge pool on Coon Creek. / Photo credit: Wisconsin DNR

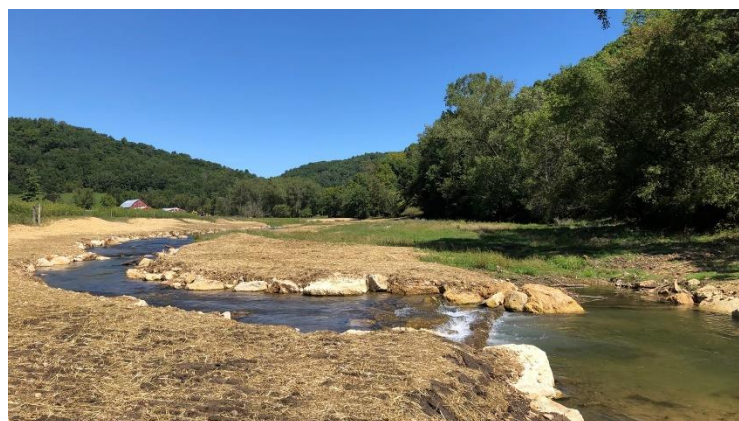
- **Fiscal Year:** 2021
- **Location:** 43.75826, -90.95404
- **Project Length:** 2,250 feet
- **Purpose:** Stabilize eroding streambanks, restoring the instream habitat that was damaged by flood events.
- **Stream Habitat Impairments:** Unstable streambanks; limited instream habitat for trout
- **Target Species:** Brown trout
- **Technique or Structure:** Bank sloping; trees/root wads; rip rap; stream crossing; plunge pools; channel shaping; grade control measures; bank shaping and planting

Coon Creek rock weir with cross channel log incorporated at the bottom and a small / Photo credit: Wisconsin DNR

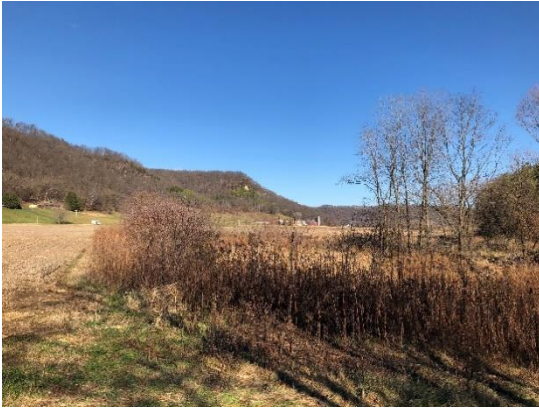
Mormon Coulee Creek (17)

Mormon Coulee Creek pre-brushing project. / Photo credit: Wisconsin DNR

- **Fiscal Year:** 2021
- **Location:** 43.74737, -91.08569
- **Project Length:** 8,131 feet
- **Purpose:** Remove the unwanted woody vegetation along riparian corridor to improve angler access
- **Stream Habitat Impairments:** Dense woody vegetation
- **Target Species:** Brown trout
- **Technique or Structure:** Tree and brush removal

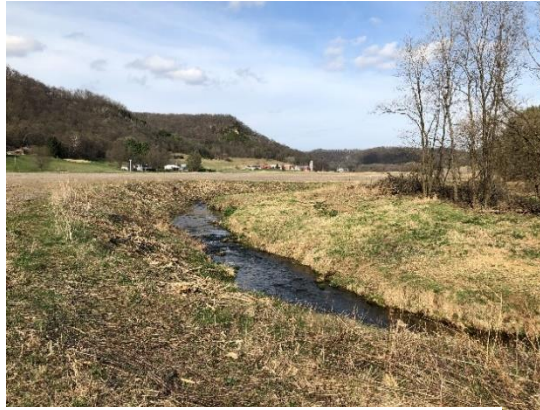
Mormon Coulee Creek post-brushing project. / Photo credit: Wisconsin DNR

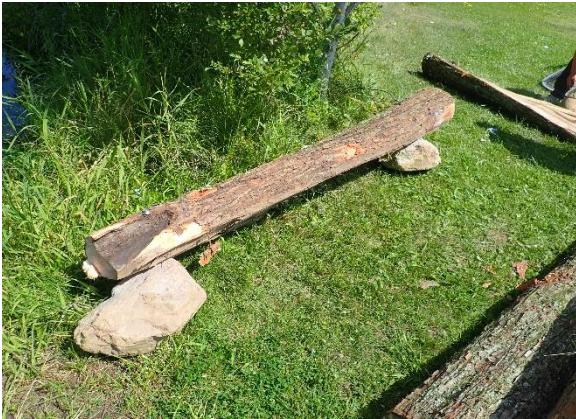
East Branch of the Eau Claire River (2)

Half logs installed on the East Branch of the Eau Claire River improve overhead cover. / Photo credit: Wisconsin DNR

- **Fiscal Year:** 2019
- **Location:** 45.23466, -89.15044
- **Project Length:** 350 feet
- **Purpose:** Improve instream habitat; reduce bank erosion
- **Stream Habitat Impairments:** Wide shallow stream bed; sedimentation in front of a handicap fishing dock; lack of overhead cover
- **Target Species:** Brook trout
- **Technique or Structure:** Half logs; brush bundles; dredging
- **Partners:** Northeast Region Trout Unlimited

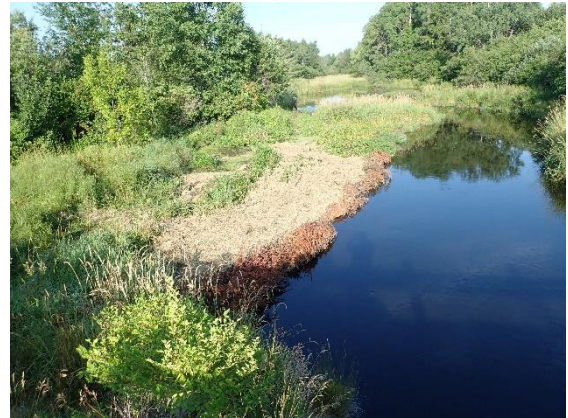
Brush bundles installed on the East Branch of the Eau Claire River. / Photo credit: Wisconsin DNR

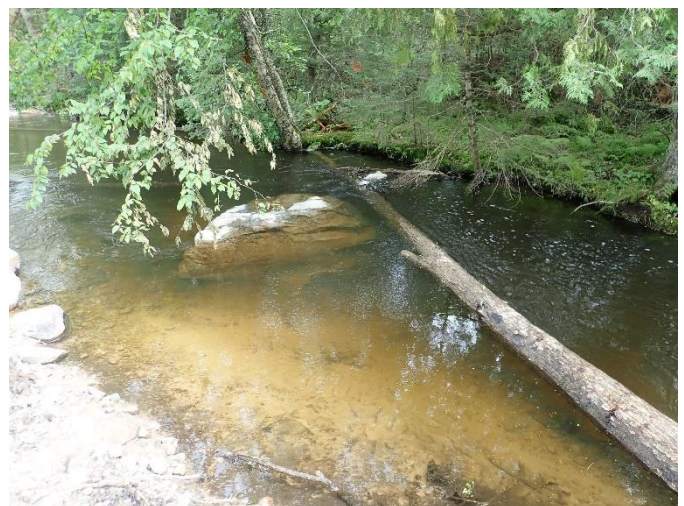
Hunting River (5)

Large rock and large wood habitat installed on the Hunting River. / Photo credit: Wisconsin DNR

- **Fiscal Year:** 2020
- **Location:** 45.37033, -89.06981
- **Project Length:** 2,500 feet
- **Purpose:** Reduce stream channel width; increase depth; increase complex woody habitat and rock habitat; improve spawning sites
- **Stream Habitat Impairments:** Widening and shallowing of the stream channel; erosion of streambanks; sedimentation; limited large complex woody and rock habitat
- **Target Species:** Brook and brown trout
- **Technique or Structure:** Channel shaping (2500 feet, 13); log/brush/rock shelters (190); brush removal (2,500 feet); point bars
- **Partners:** Trout Unlimited Northeast Region

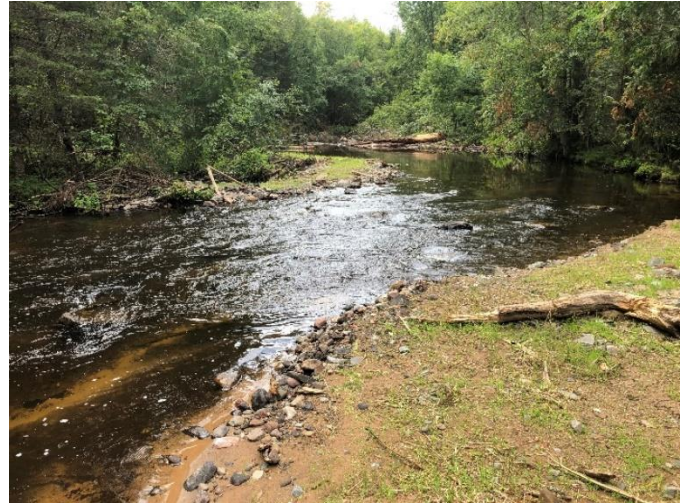
Hunting River (6)

*Point bar shortly after construction on the Hunting River.
/ Photo credit: Wisconsin DNR*

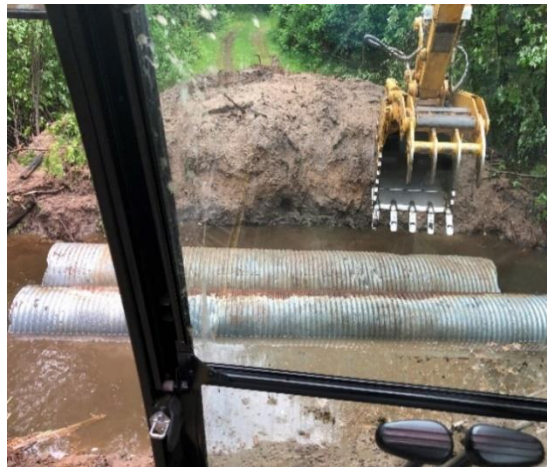
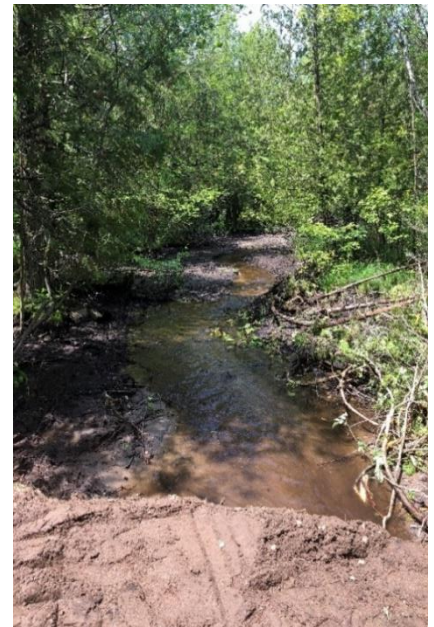
- **Fiscal Year:** 2019
- **Location:** 45.149341, -88.831624
- **Project Length:** 50 feet
- **Purpose:** Replace impaired culvert; reduce ponding; increase flow; restore aquatic connectivity
- **Stream Habitat Impairments:** Improperly set forest road culvert crossing; sedimentation, siltation and ponding of water above the crossing; barrier to fish movement.
- **Target Species:** Brook and brown trout
- **Technique or Structure:** Culvert replacement

*Left photo - Culverts being removed and reset. / Photo credit: Wisconsin DNR
Right photo – The restored stream channel above the crossing after properly installing culvert. / Photo credit: Wisconsin DNR*

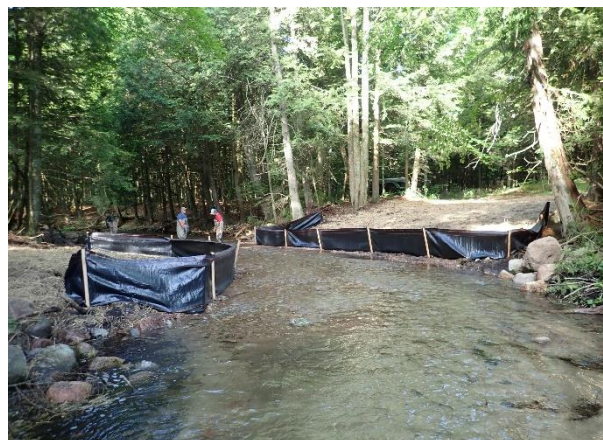
- **Fiscal Year:** 2019
- **Location:** 45.08597, -89.07893
- **Project Length:** 50 feet
- **Purpose:** Replace culvert crossing with instream crossing; restore aquatic connectivity
- **Stream Habitat Impairments:** Sedimentation; siltation; aquatic organism barrier; ponding of water above the crossing
- **Target Species:** Brook and brown trout
- **Technique or Structure:** Culvert replacement

Red River project site where the culvert was removed and replaced with instream crossing. Silt fence to retain runoff until slopes are stabilized. / Photo credit: Wisconsin DNR

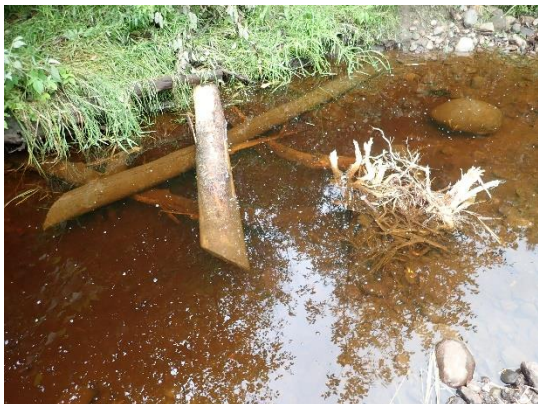
Averill Creek (1)

Complex wood habitat installed on Averill Creek. / Photo credit: Wisconsin DNR

- **Fiscal Year:** 2019
- **Location:** 45.3492, -89.8830
- **Project Length:** 800 feet
- **Purpose:** Remove excessive brush; stabilize banks; narrow stream channel; increase trout habitat
- **Stream Habitat Impairments:** Dense tag alder growth; wide and shallow stream channel; elevated road crossing
- **Target Species:** Brook trout
- **Technique or Structure:** Brush removal; point bar construction; channel excavation; wood habitat complex; instream rock

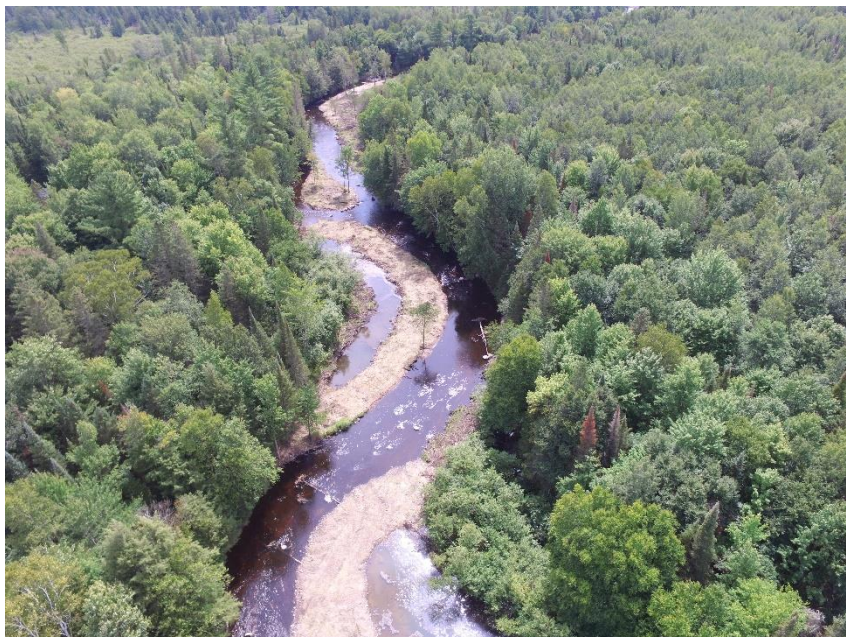
Aerial view of the Prairie River habitat project showing point bar construction, boulder clusters and woody habitat. / Photo credit: Dave Curran

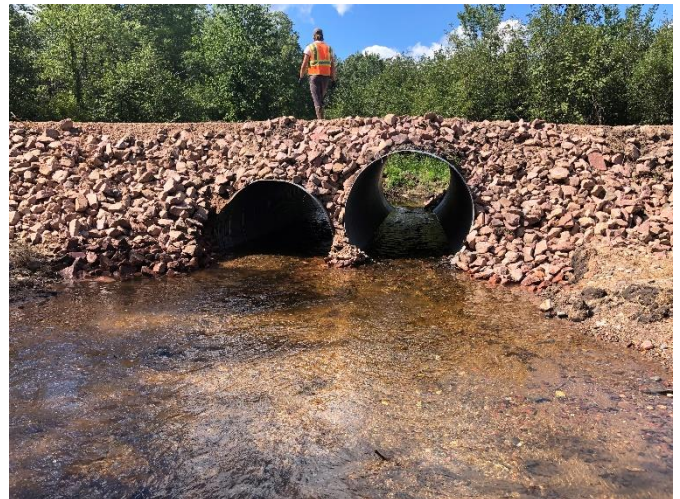
Newly installed culverts on Spring Creek. / Photo credit: Wisconsin DNR

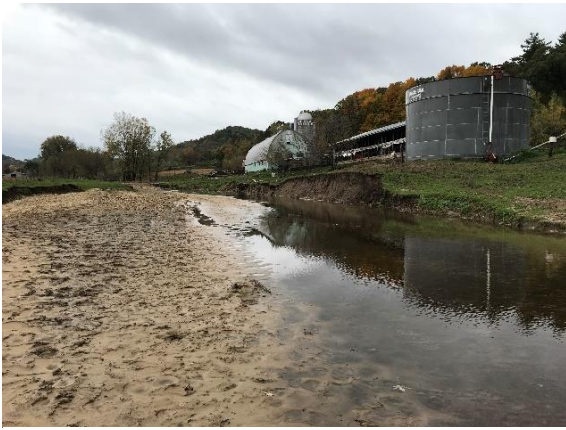
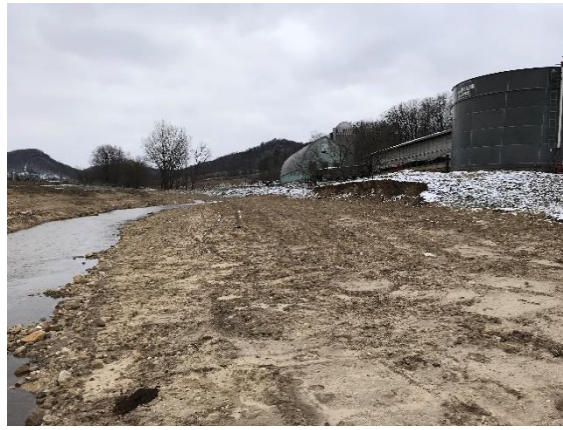
Left photo - Post-flood event location of Unnamed Creek 6-16's channel threatening manure storage tank. / Photo credit: Wisconsin DNR
 Right photo - Unnamed Creek 6-16 after being relocated back to pre-flood channel. / Photo credit: Wisconsin DNR

- **Fiscal Year:** 2019
- **Location:** 43.79702, -90.77186
- **Project Length:** 2,485 feet
- **Purpose:** Remove flood debris that was constricting the floodway; reshape the stream channel and the streambanks
- **Stream Habitat Impairments:** Constricted floodway; a widened shallow stream channel; streambank erosion
- **Target Species:** Brook trout
- **Technique or Structure:** Bank sloping; material removal; channel shaping; grade control measures; bank shaping and planting

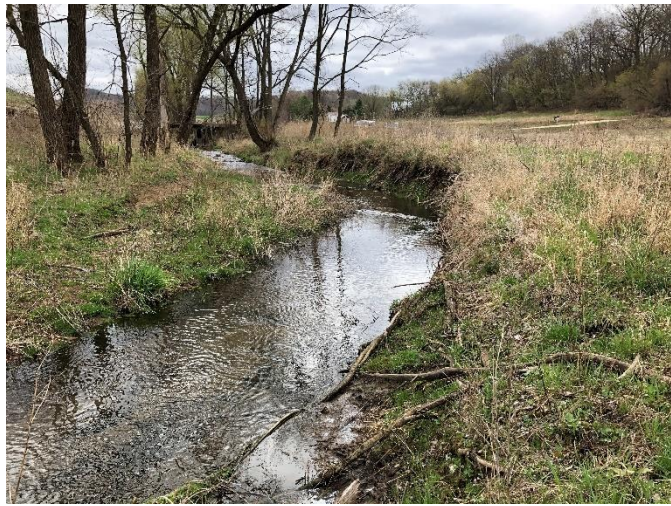
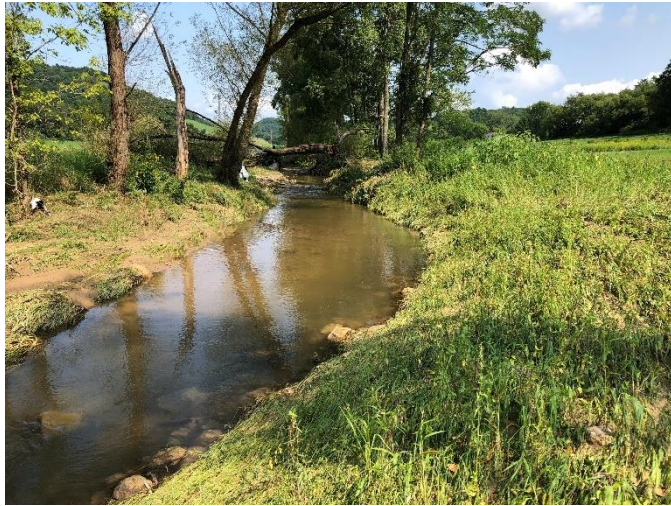
Unnamed Creek / Halls Valley Creek (3)

Left photo - Eroding high streambank prior to habitat work on Unnamed Creek / Halls Valley Creek. / Photo credit: Wisconsin DNR

Right photo – Same streambank that after it had been sloped, rip rap installed and seeded. / Photo credit: Wisconsin DNR

- **Fiscal Year:** 2021
- **Location:** 43.81025, -90.73688
- **Project Length:** 290 feet
- **Purpose:** Stabilize streambank's third streambank; reconnect stream to floodplain
- **Stream Habitat Impairments:** Unstable high streambanks
- **Target Species:** Brook and brown trout
- **Technique or Structure:** Bank sloping; rip rap; material removal; bank shaping and planting
- **Partners:** Monroe County LCD (Cooperator)

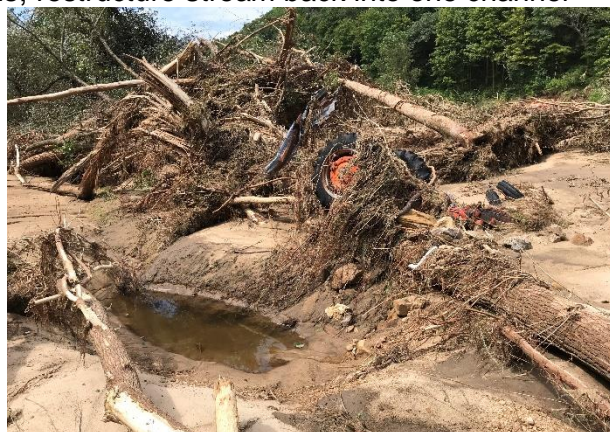
Flood debris, including tractor, blocking stream channel on Rullands Coulee Creek. / Photo credit: Wisconsin DNR

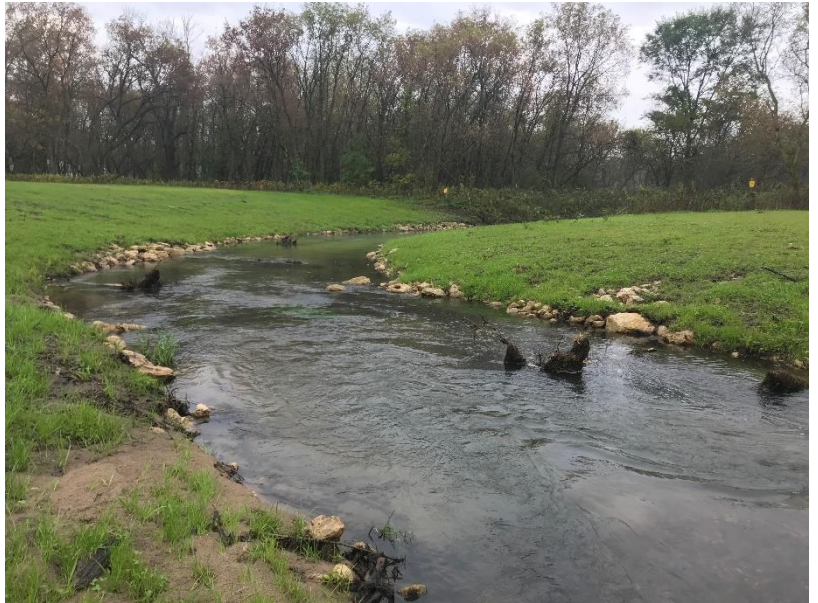
Trimbelle River post-habitat work, instream boulders, root wads and bank sloping. / Photo credit: Wisconsin DNR

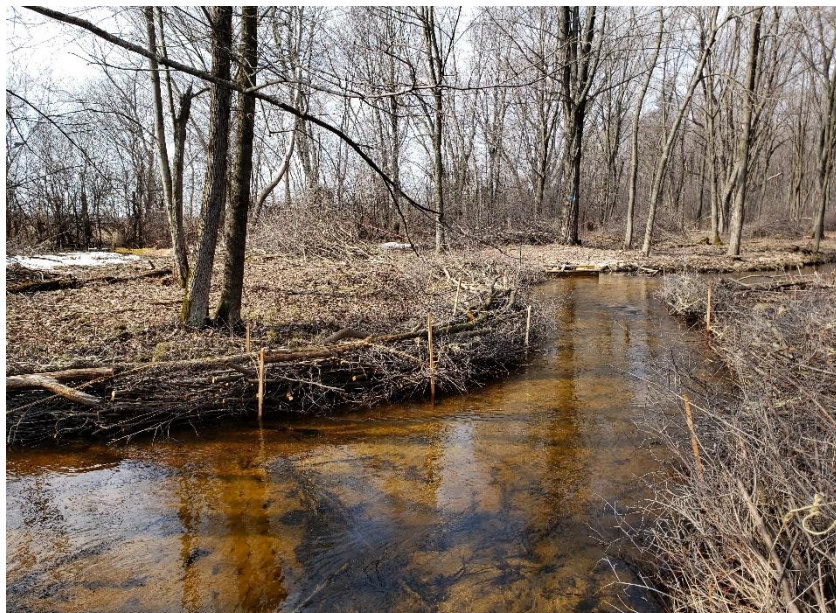
Plover River after riparian tag alder and buckthorn were removed and brush bundle/mattresses were installed. / Photo credit: Wisconsin DNR

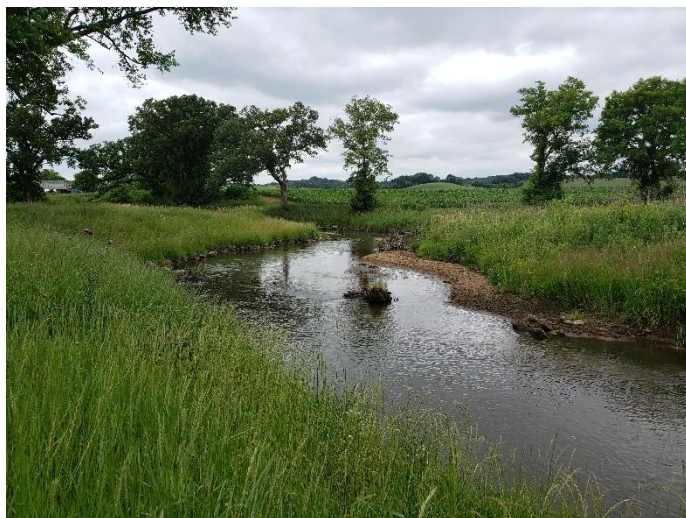
Elk Creek (2)

Elk Creek post-habitat work. / Photo credit: Wisconsin DNR

- **Fiscal Year:** 2021
- **Location:** 44.4079, -91.4224
- **Project Length:** 3,200 feet
- **Purpose:** Stabilize eroding streambanks; improve adult trout habitat
- **Stream Habitat Impairments:** Wide and shallow stream channel; excessive sand bed load; eroding streambanks; lack of overhead cover
- **Target Species:** Brook and brown trout
- **Technique or Structure:** Streambank sloping; rip rap; weir; wing deflector; log, root wad and boulder revetments; brush removal
- **Partners:** Elk Rod and Gun Club

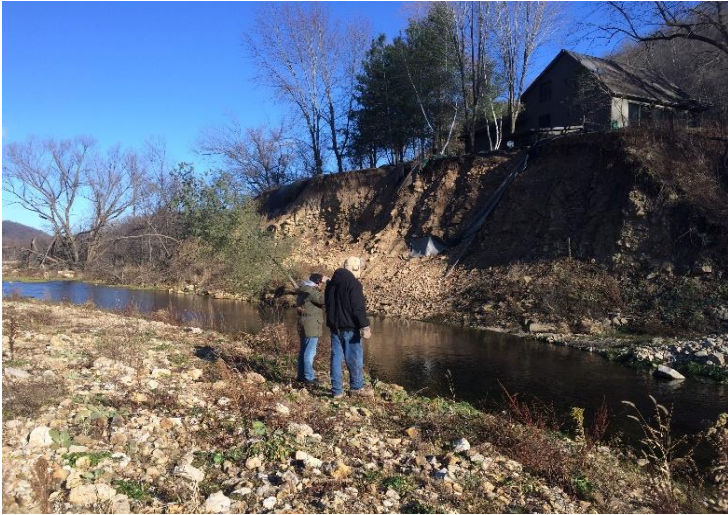
Eroding streambank, Frohock Creek, pre-project. / Photo credit: Wisconsin DNR

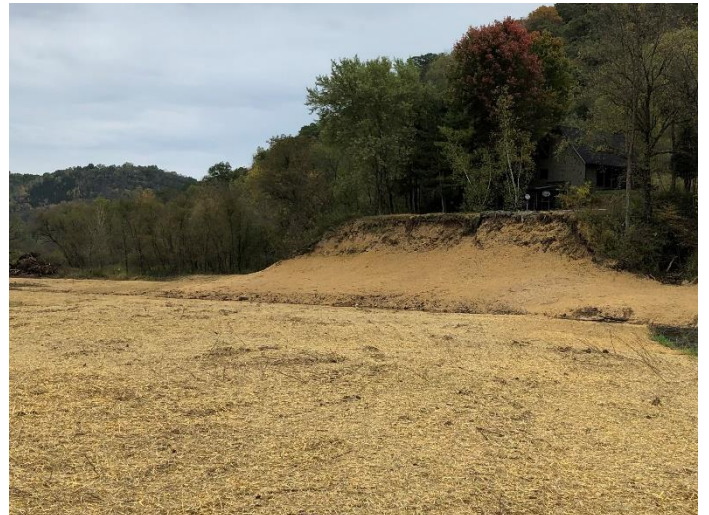
Eroding streambank, Frohock Creek, post-project. / Photo credit: Wisconsin DNR

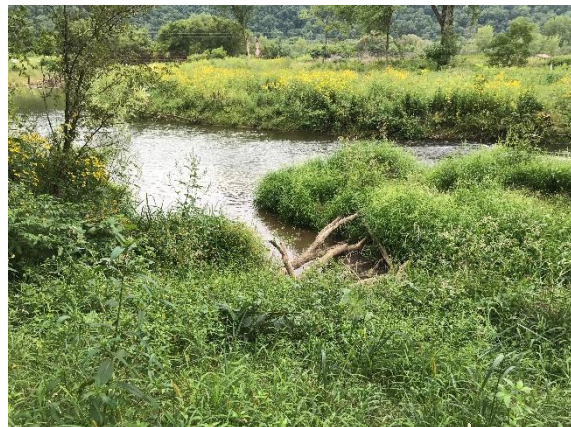
North Fork Bad Axe River (10)

Constricted backwater refuge on the North Fork Bad Axe River. / Photo credit: Wisconsin DNR

- **Fiscal Year:** 2019
- **Location:** 43.59053, -91.04319
- **Project Length:** 545 feet
- **Purpose:** Stabilize an eroding streambank and create instream habitat for trout; create habitat for reptiles and amphibians
- **Stream Habitat Impairments:** Unstable streambanks; lack of cover for trout; constricted floodway
- **Target Species:** Brown trout
- **Technique or Structure:** Streambank sloping; rip rap; material removal; streambank shaping and planting; log, root wad and boulder revetments; brush removal; backwater refuge

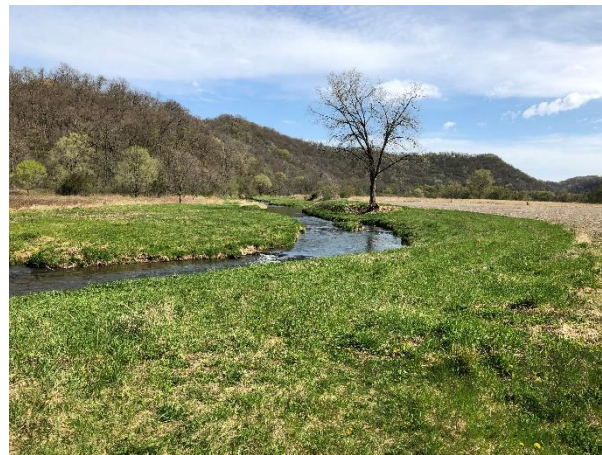
North Fork Bad Axe River (13)

Post brush removal along the North Fork Bad Axe River. / Photo credit: Wisconsin DNR

- **Fiscal Year:** 2021
- **Project Length:** 5,544 feet
- **Location:** 43.59248, -91.03818
- **Purpose:** Remove the unwanted woody vegetation; improve angler access; open up riparian floodway.
- **Stream Habitat Impairments:** Dense woody vegetation
- **Target Species:** Brown trout
- **Technique or Structure:** Tree and brush removal

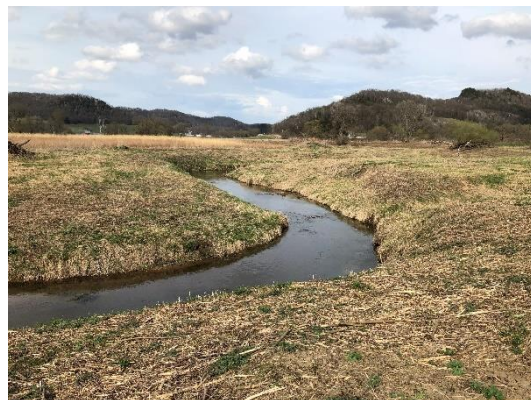
Spring Coulee Creek (23)

Post brush removal on Spring Coulee Creek. / Photo credit: Wisconsin DNR

- **Brushing**
- **Fiscal Year:** 2021
- **Location:** 43.71047, -90.99834
- **Project Length:** 2,323 feet
- **Purpose:** Remove undesirable woody vegetation; improve angler access; streambank erosion
- **Stream Habitat Impairments:** Dense woody vegetation
- **Target Species:** Brown trout
- **Technique or Structure:** Brush removal

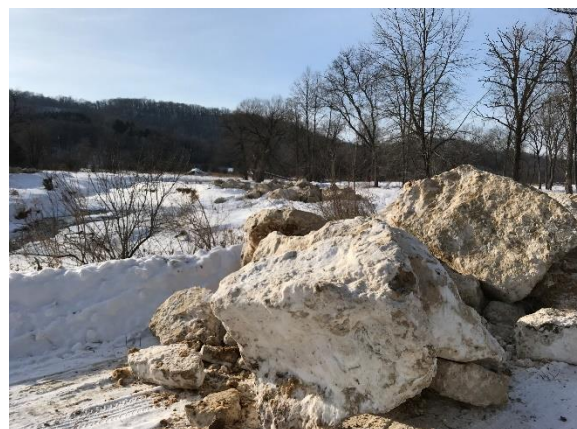
Weister Creek (37)

Rock staged along Weister Creek ready to be installed. / Photo credit: Wisconsin DNR

- **Fiscal Year:** 2019
- **Location:** 43.63471, -90.65591
- **Project Length:** 2,910 feet
- **Purpose:** Stabilize streambanks; create cover for trout; reconnect stream to floodplain
- **Stream Habitat Impairments:** Unstable streambanks; lack of cover for trout; nuisance vegetation
- **Target Species:** Brown trout
- **Technique or Structure:** Streambank shaping and planting; brush removal
- **Partners:** Kickapoo Valley Reserve

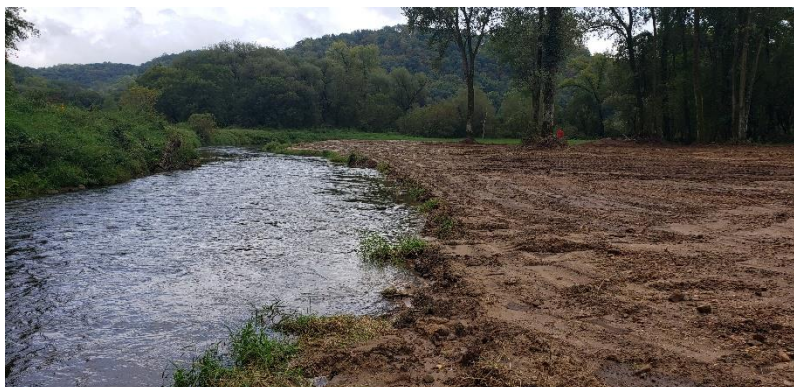
Streambank sloped to connect river to floodplain on the West Fork of the Kickapoo River. / Photo credit: Wisconsin DNR

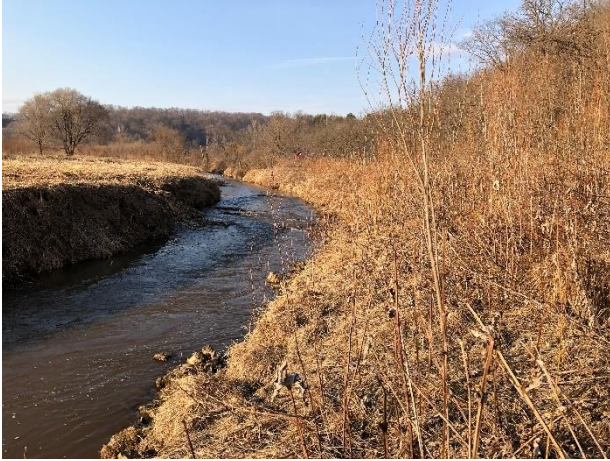
West Fork of the Kickapoo River (40)

Stretch of the West Fork of the Kickapoo River scheduled for brushing and mowing. Left streambank was completed prior to picture being taken. / Photo credit: Wisconsin DNR

- **Fiscal Year:** 2021
- **Location:** 43.66048, -90.78476
- **Project Length:** 6,389 feet
- **Purpose:** Remove undesirable woody vegetation; improved angler access; increase capacity of floodway
- **Stream Habitat Impairments:** Dense woody vegetation
- **Target Species:** Brown trout
- **Technique or Structure:** Material removal
